PARTNERSHIP PROJECTS

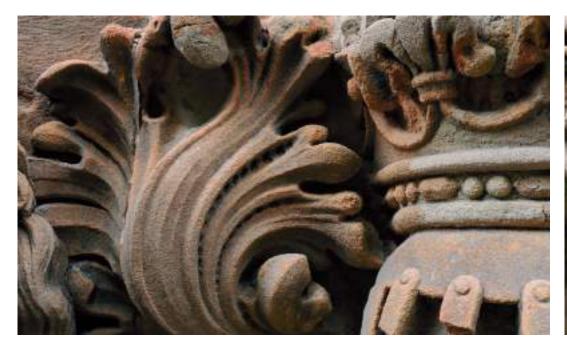
CENTRAL LOCAL COURTHOUSE

A stone safety inspection was undertaken in October 2009. A report with recommendations was prepared based on the inspection which identified the coat of arms as in need of urgent repairs.

Conservation works commenced in December 2010 to areas 2, 3 and 4 focusing on the coat of arms. Associated works included the replacement of the defective leadwork, minor stone replacement and repointing of open joints. The coat of arms was stabilised and a rubber mould was produced for proposed future works.

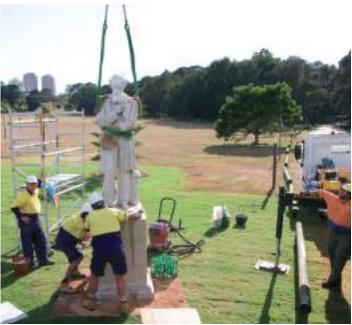
CHARLES DICKENS STATUE

In 1972 the statue of Dickens was removed from Centennial Park due to vandalism and was kept in storage. Since this time the statue has been held in a number of locations until 2009 when it was relocated to Heritage Services, NSW Public Works' Stoneyard for reconstruction.

In 2010/11 conservation works included reconstruction of the missing head, scroll, quill and finger. These elements are considered integral to recognising the statue of Dickens.

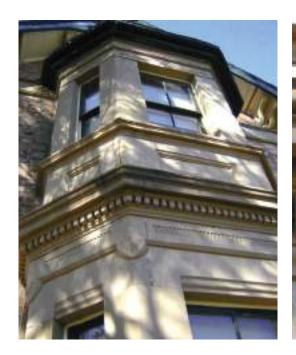
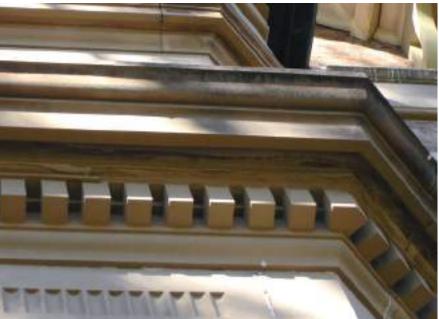
HUNTER SCHOOLS STRATEGY

Generally the deterioration of the buildings is due to the lack of cyclic maintenance, however in some cases inappropriate repairs have been carried out, for example inappropriate mortars used for pointing, which contribute to the deterioration of the stonework.

The strategy identifies and prioritises conservation works based on the level of deterioration of fabric as well as the potential public safety risk involved.

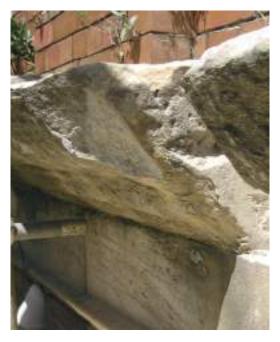
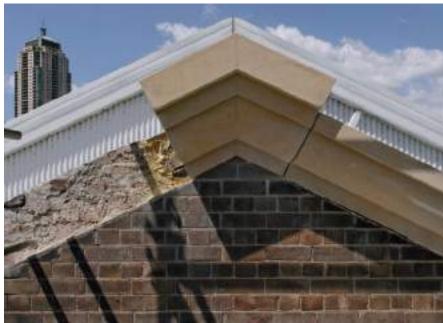
POWERHOUSE MUSEUM

Stone safety inspections of the Boiler Hall and Office Building were undertaken in 2006 and 2008. At this time it was noted that the stone cornices and copings of both buildings were severely deteriorated, exacerbated by ineffective past repairs.

Stone conservation works undertaken in the 2010/11 program have included the replacement of deteriorated stone elements to the north façade of the Boiler Hall and the east and north façade of the Office Building, as well as brick repair and repainting. The works are part of a larger program of stone conservation works planned for the historic buildings.

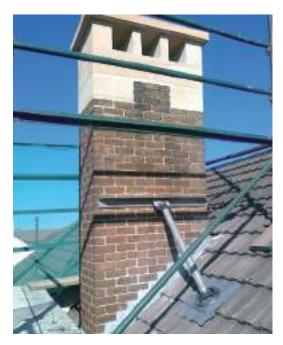
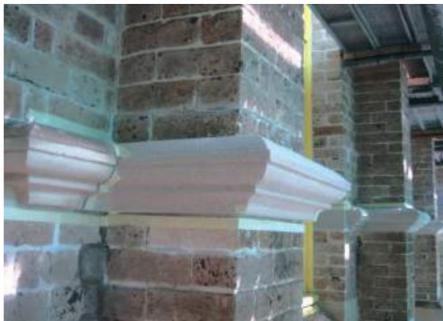
WAVERLEY PUBLIC SCHOOL

Stone safety inspections were undertaken in 2005 and 2009. At this time it was noted that the stone caps of the chimneys were severely deteriorated and their conservation was a high priority. Stone elements of the north façade were also noted as requiring conservation.

Construction works commenced in late 2010 and included the replacement of deteriorated stone caps and units to the chimneys as well as the northern elevation of the building. Seismic stabilisation of the chimneys was also undertaken in accordance with the relevant Australian Standards.
