EXECUTIVE SPONSORS

MESSAGE

2019/20 SNAPSHOT

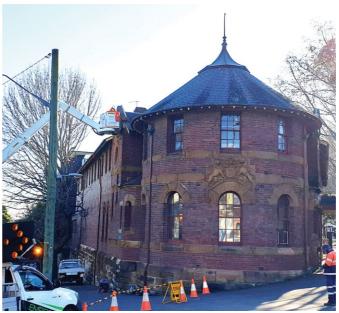
Bottom left image: Former Darlinghurst Police Station. 100kgs of loose stone was removed during the inspection.

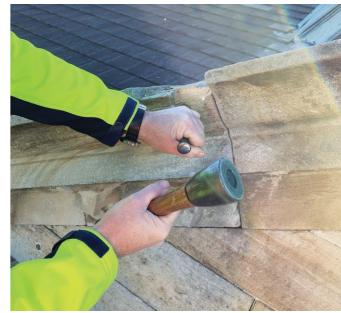
Top right image: Loose, cracked stonework being removed during an inspection.

Bottom right image: A stonemason carefully removes a section of cracked stonework from a gable coping.

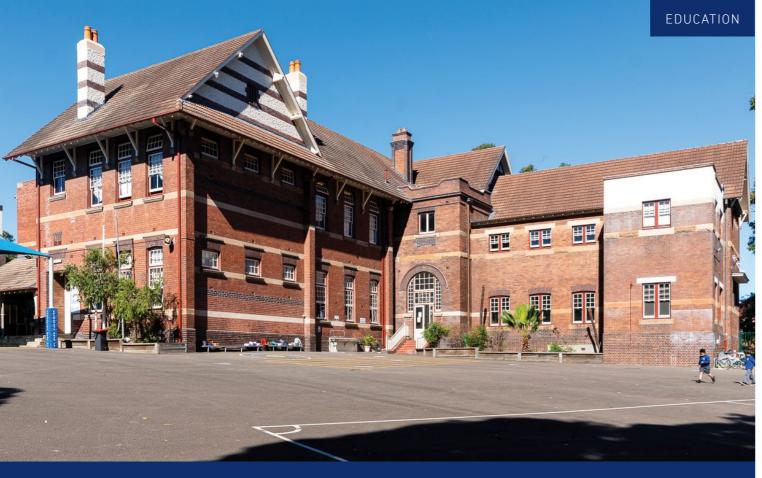
GARDENERS ROAD PUBLIC SCHOOL - STAGE 2

The sandstone sills were in poor condition due to deferment of necessary repairs. Dangerous stone as previously removed to mitigate risk of falls during a condition audit; however, this accelerates the rate of decay requiring durable repairs within 2 years of removing delaminated stone. Vegetation growing in the joints and subsequent weather exposure had resulted in movement to the chimney capping stones resulting in a safety hazard.

Top image: Gardeners Road Public School

Lower image: Completed conservation works to window awning

Stage 2 works focussed on the eastern elevations of the building and included rebuilding a section of parapet roof, strengthening window arches, stone sill replacement, painting of timber joinery and installation of bird proofing. Minor repairs were carried out to prolong the life of the existing concrete tile roof with the roof plumbing wholly replaced with larger profile gutters and downpipes to increase capacity to manage heavier and more frequent rain events as a result of climate change.

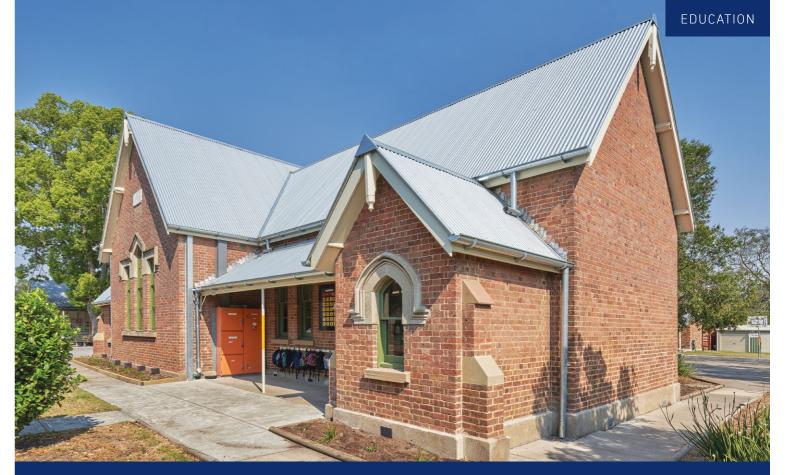
GRETA PUBLIC SCHOOL

Top image: Greta Public School **Lower image**: Completed window repairs

Conservation works included cleaning and decontamination of roof spaces, repairs to corroding arch bars and rendered hood moulding, synthetic repairs to stone windowsills, stone indents and replacement to windowsills, chimney breast, ashlar, plinth course and chimney caps, masonry cleaning, repointing and desalination, timber repairs and repainting. Strengthening of window heads and chimneys was completed to improve structural integrity. Lead weatherings were installed to the chimney caps to protect against water ingress.

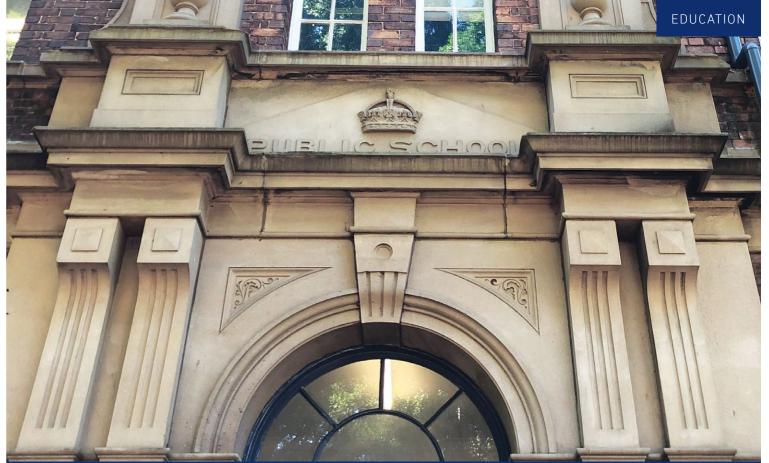
YUDI GUNYI SCHOOL - STAGE 1

Top image: Decorative stonework to main entrance prior to the commencement of conservation works

Lower image: Reinstated tuckpointing and raddling to window arches

There was physical evidence of earlier brickwork finishes, in particular tuckpointing and raddling. After consultation and advice from a specialist heritage bricklayer, a decision was made to reinstate original finishes above and below the windows to give an idication of how the building originally looked.

The strengthening of the bell tower was undertaken to improve its structural integrity and ensure this vulnerable element was able to withstand potential seismic activity.

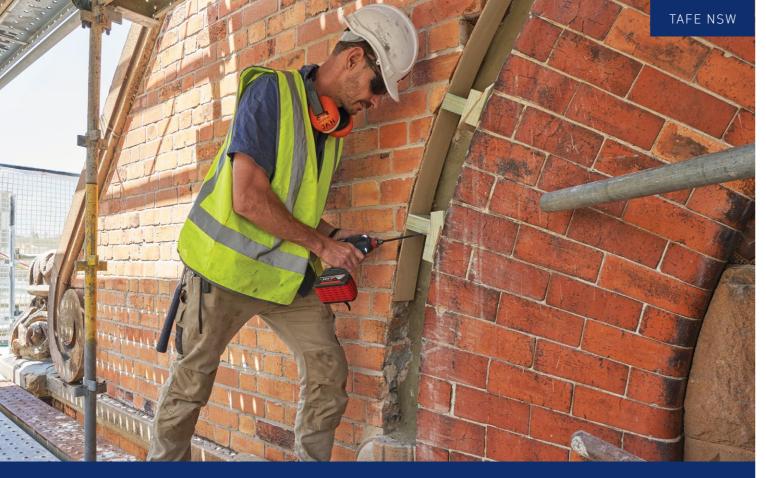
NEWCASTLE TAFE HUNTER STREET CAMPUS

Top image:Temporary propping is installed following the removal of the sandstone voussoirs scoped for replacement.

Lower image: Decorative carving features Australian flora and fauna

Conservation works included replacement of deteriorated sandstone units, including 5 of the unique flora and fauna carvings, installation of protective lead weatherings, stormwater improvements, repairs and repainting of cast-iron downpipes, repainting of the external timber joinery, window repairs, restoration and repointing of masonry mortar joints.

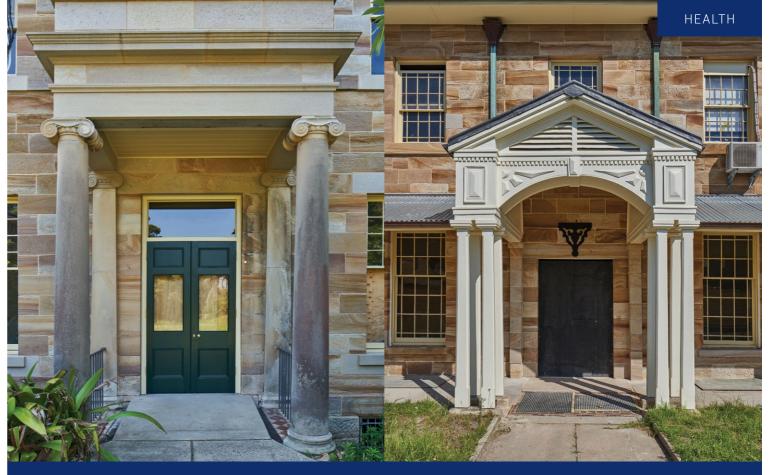
GLADESVILLE HOSPITAL BUILDING 38

Top images: Completed conservation works to the North and South entry **Lower image**: Ionic capital

Conservation works were carried out to remediate the structure, this included repair and reconstruction of the internal rotten timber wall plates, lintels and joists at the basement and ground floor levels.

Repairs and investigation of the stormwater trench on the south side were carried out to diagnose the cause of severe water ingress to the basement.

Once the structural works were completed, stone conservation works, verandah repairs and interpretation works on the north façade were undertaken.

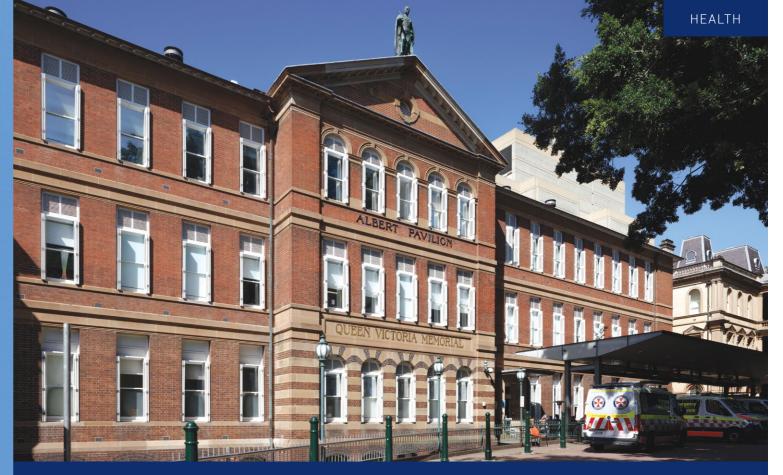
ROYAL PRINCE ALFRED HOSPITAL

Top image: Albert Pavilion

Lower image: Completed timber windows and shutter conservation works

Works for Stages 2 & 3 included cleaning of biological growth from the facade, repairs to windows, window shutters and sandstone repairs to the front fence. The introduction of lead weatherings to prolong the life of the original and new sandstone and repointing of open joints to stop water penetrating the building. General maintenance including painting of windows and cleaning lead light glass was also carried out whilst the scaffold was in place.

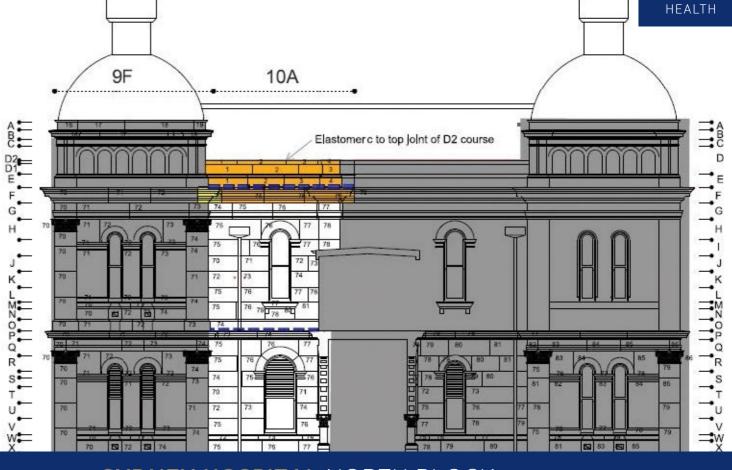
SYDNEY HOSPITAL NORTH BLOCK

Top image: Architectural drawing of works completed

Lower image: New lead weatherings installed to the projecting horizontal elements

Focusing on the replacement of deteriorated high-level parapet stone that had reached the end of its functional life. Lead weatherings were introduced to the projecting horizontal elements to prolong the life of the original sandstone, improve water shedding and also to reposition the drip edge further away from significant sandstone facade elements.

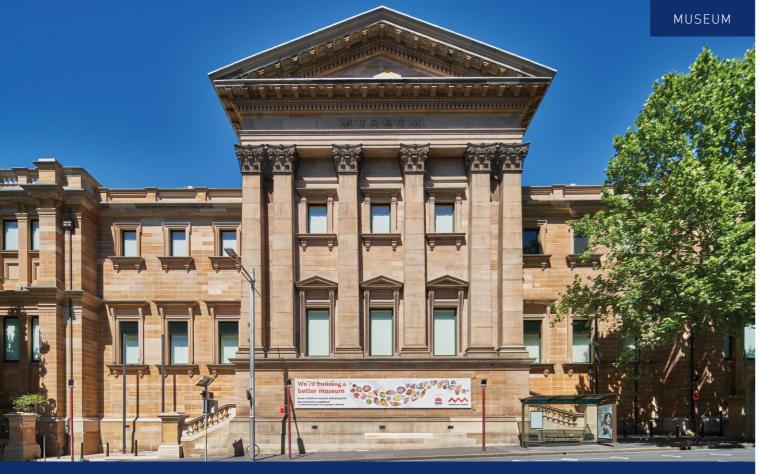
AUSTRALIAN MUSEUM

A Safety Audit was carried out in 2019 and there was evidence of advanced deterioration to upper overhanging stone elements. Stone mortar joints were eroded and allowing water ingress, leading to further deterioration. Previous stone patches were cracked and failing, timber window joinery was degraded, and the façade was stained with biological growth around defective downpipes.

Top image: Australian Museum following completion of conservation works

Lower image: View of conservation works to entry stairs

The objective of the project was to prolong the life of the significant fabric and provide quality long-term repairs (60+ yrs). The conservation approach was to replace 'like for like', record all interventions and retain as much of the original fabric as possible.

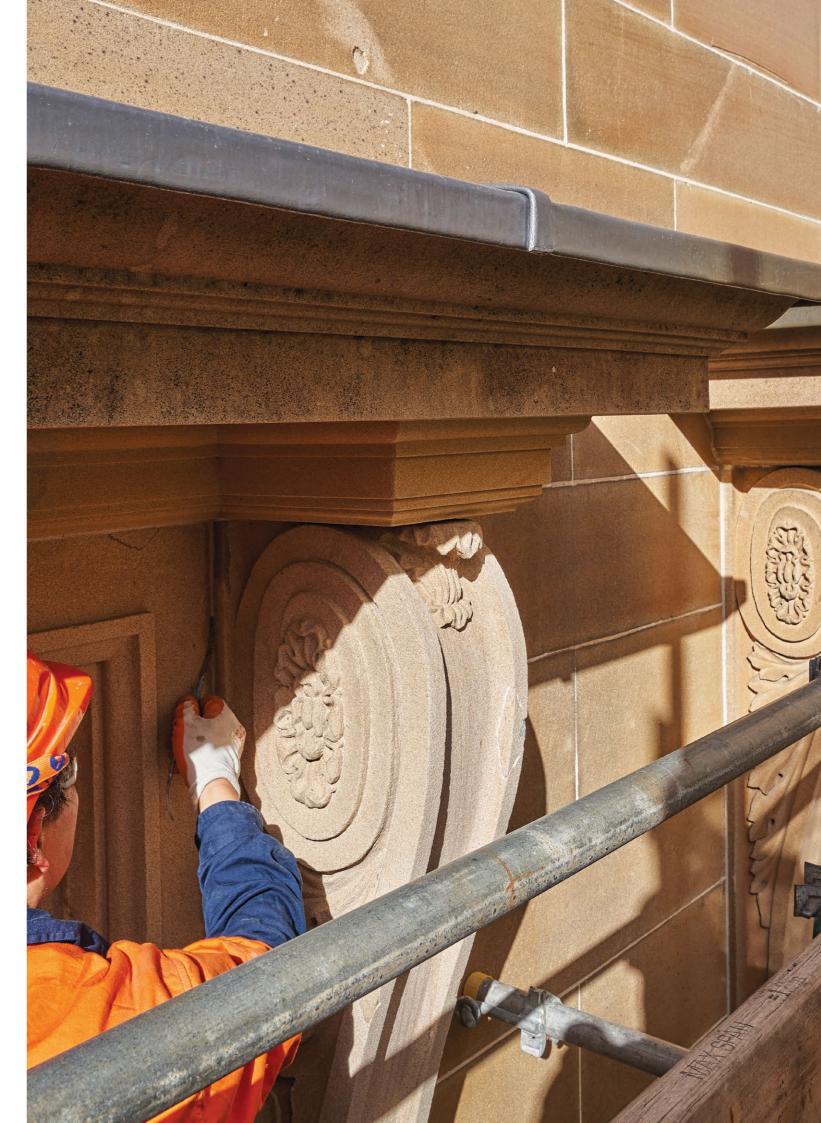
Right page image: Removal of a section of defective pointing.
