# 2024-2025

Minister's Stonework Program | Annual Achievements

NSW Public Works

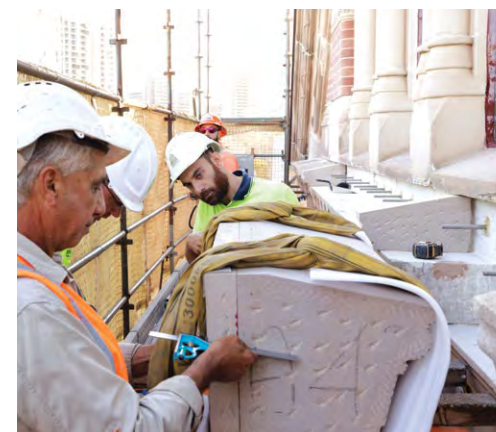
**Top:** Replacement stone being delivered to site

**Below:** Installation requires precision and accuracy

**Left:** Completed external work

The 2024 conservation of the main gable, presented a rare opportunity to restore the building's artistic and educational intent through the reinstatement of 32 missing carvings, which included classical mouldings and highly individualized flora and fauna motifs.

As the nation's earliest institution to formally train stonemasons, the NSW Government stonemasons undertaking the carving reinstatement felt a connection to their forebears. As the beneficiaries of the powerful continuity of craft, working the pedagogical and architectural legacy of their own profession. Additional items in the scope of work completed included stone replacement, facade cleaning, lead weathering, painting and timber repairs, and birdproofing.

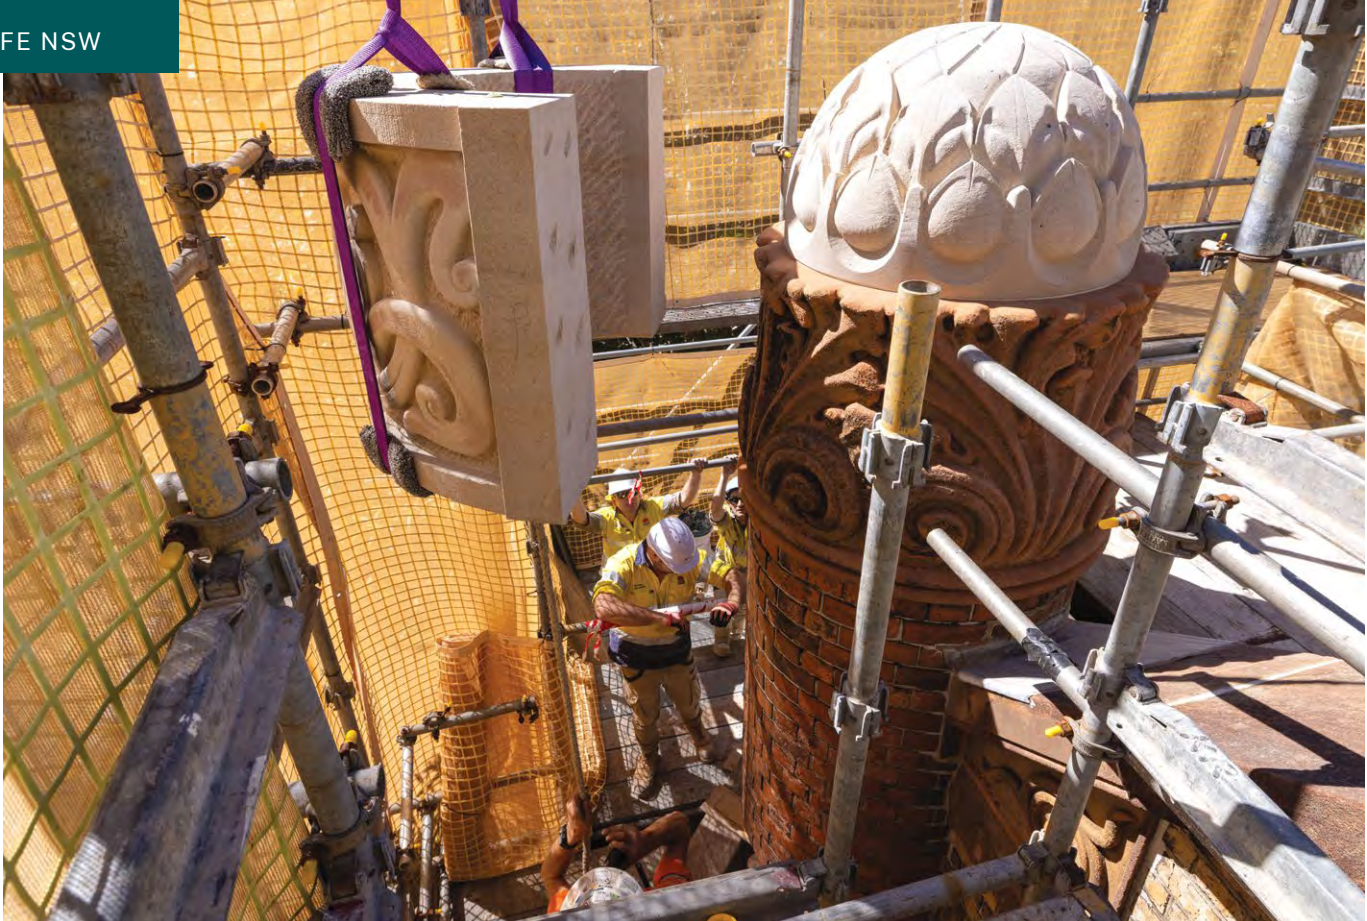
## ULTIMO TAFE BUILDING C, THE MUSE

**Top:** Replacement carvings being installed

**Below:** Securing replacement stone

**Right:** Terracotta tiles and other decorative elements

The purpose of the works is to prolong the life of significant building fabric and ensure the building's long-term conservation. This was achieved by repairing and conserving significant building fabric and replacing defective fabric which had reached the end of its functional life. The proposed work was developed and scoped to retain as much of the existing exceptionally significant fabric as possible. Roofing works were completed in the 2020-2021 financial year. Stage 2 works, this financial year, focusing on the North and South Facade, included synthetic stone repairs to cracked/damaged stone retained in situ, stone replacement, repair of stone lintels, repointing of sandstone and brick joints, re-replacing broken terracotta tiles, repairs to highly weathered timber windows and doors, external cleaning to remove biological growth, bird droppings and dirt, provide new mesh to wall vents, and installation of lead weathering and bird proofing.

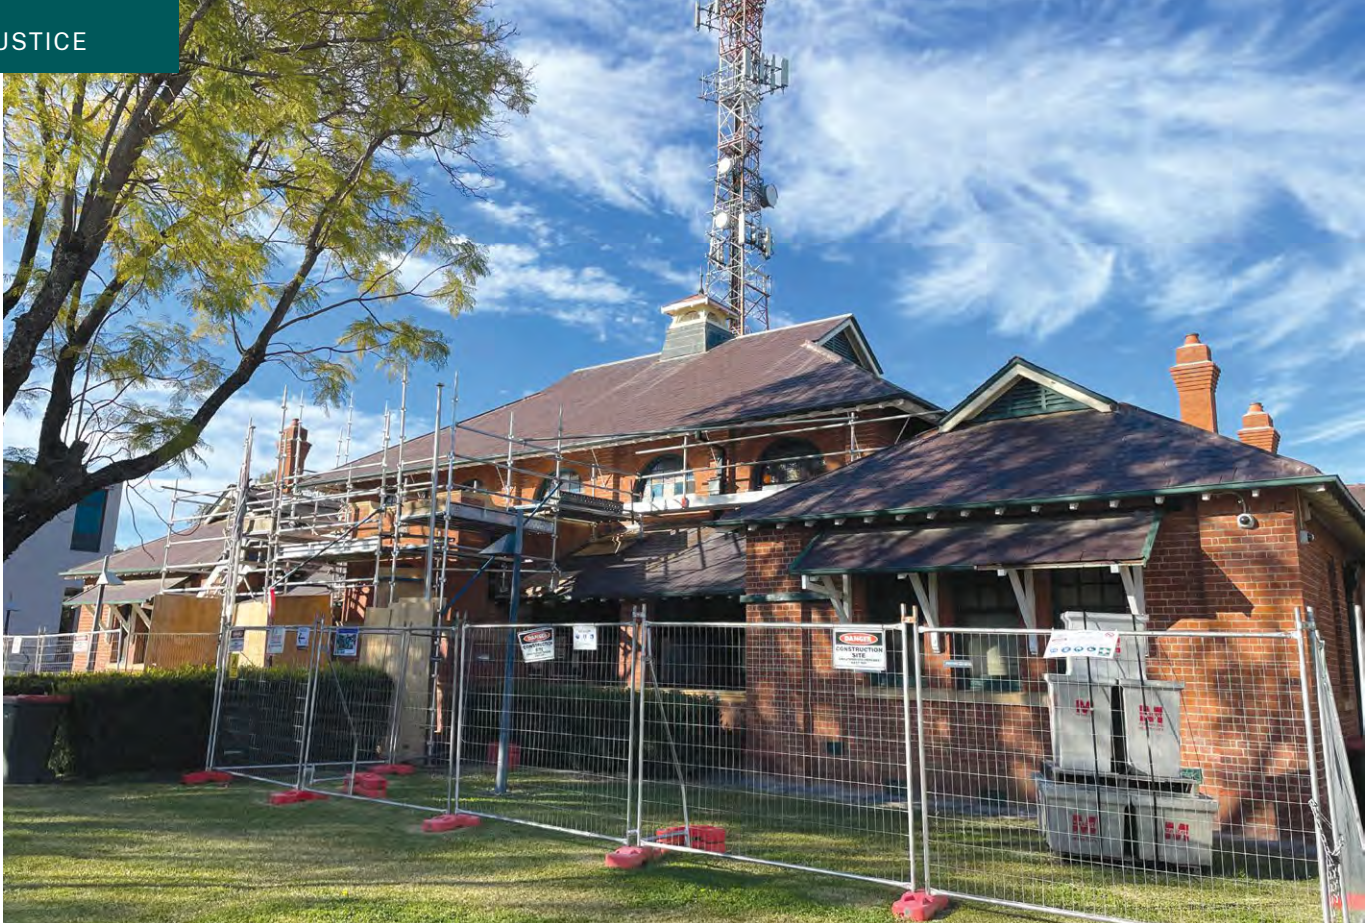
MOREE COURTHOUSE

In 2019, a detailed *from the ground* condition audit of Moree Courthouse was completed. Signs of deterioration to the roof, timber work and masonry were identified. The findings resulted in the repair of Moree Courthouse being prioritised.

Conservation works to the Moree Courthouse included a range of repairs including to the slate roof, rainwater goods, the chimney, timber elements and windows. Works also included cleaning and repointing of stone and replacement of metal fixings and bird proofing.

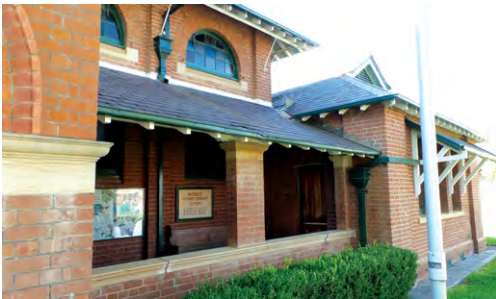
**Top image:** Construction underway  
**Lower image:** Moree Courthouse prior to works

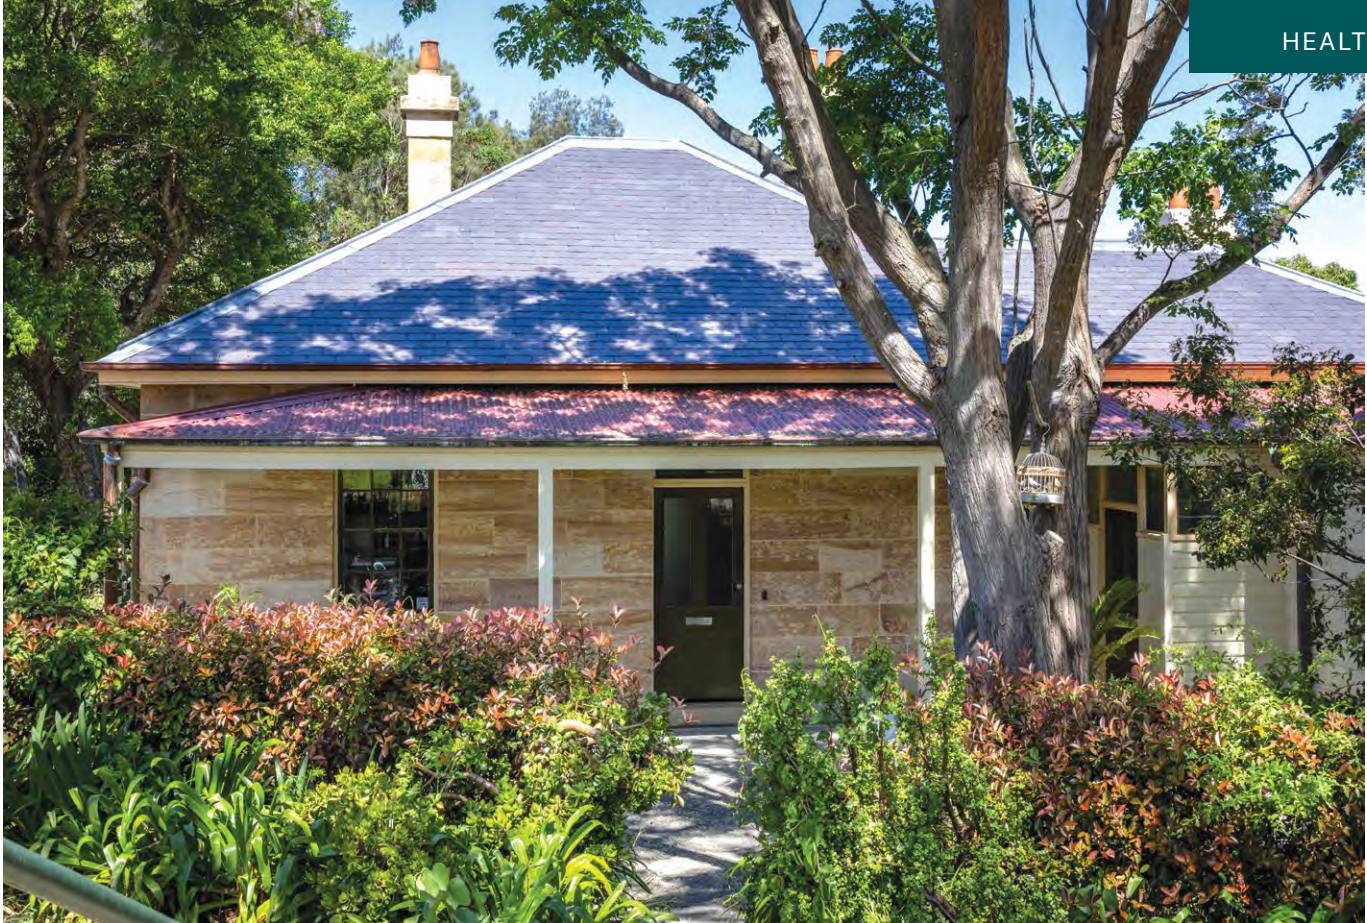
GLADESVILLE HOSPITAL BUILDING 17

A condition audit of Building 17, was undertaken in January 2021 which included a detailed inspection of the external building facades and roof from an elevated work platform. At this time, the building was found to be generally in sound condition.

Regular inspections of the building were undertaken following the condition audit and in subsequent years the chimney stones had shown signs of deterioration, resulting in the repair of Building 17 being prioritised.

Salt ingress from the later concrete verandah floor slab had severely affected the base course stones on the front, north elevation; requiring their full replacement. An air drain was installed to provide separation between concrete and stonework. The new drain will prevent salt damage to the new stonework and extend its functional life.

Non-breathable, modern paint was removed from the rendered 1919 addition and breathable limewash, a traditional finish, was applied to allow moisture to move through the masonry.

The slate roof was at the end of its functional life and was fully replaced with new Penrhyn Welsh slate to match the original.

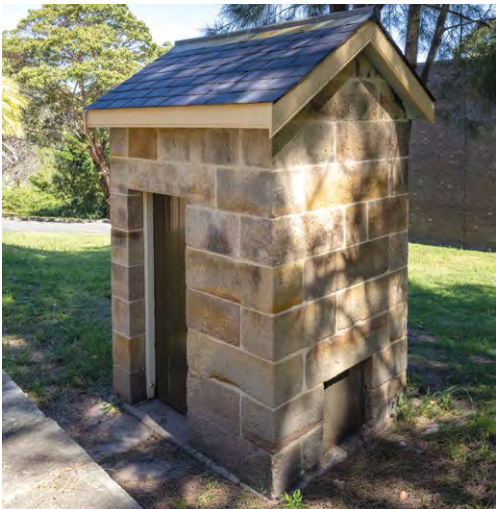
**Top:** Completed external works  
**Below:** Outbuilding

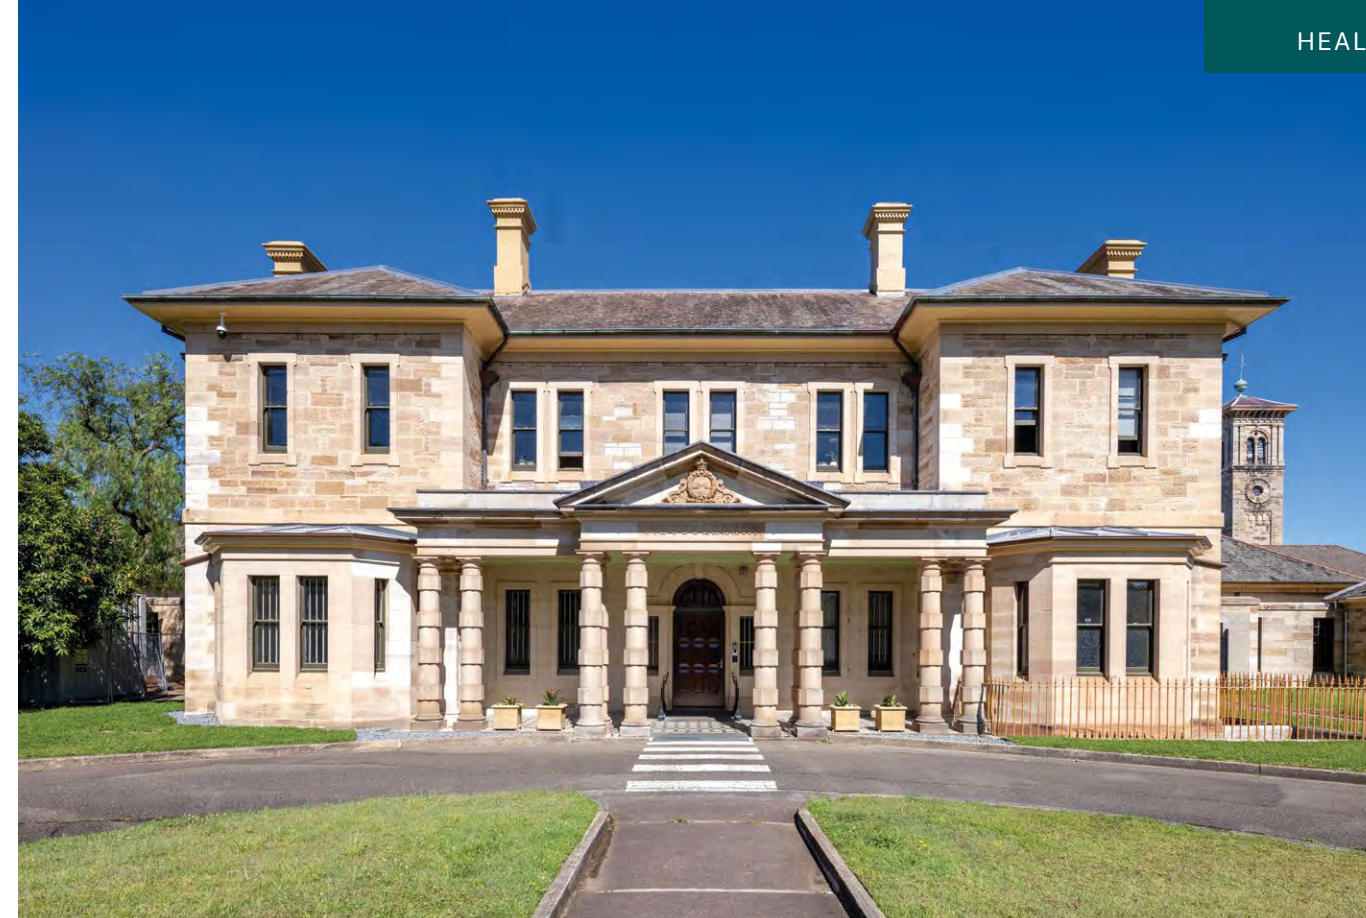
## CALLAN PARK, KIRKBRIDE BUILDING 13

Overhanging eaves offer some weather protection to the majority of the stonework within the Kirkbride Complex; the exception to this is the formal entrance entablature of Building 13. The pediment stones had deteriorated due to weather exposure and continuous wetting and drying for over 140 years.

Conservation works to Building 13 were prioritised to prevent further sandstone deterioration. Lead weatherings were introduced to the top of the pediment and cornice to shed water away from the carvings and prevent water from continuing to affect the face of the carved elements.

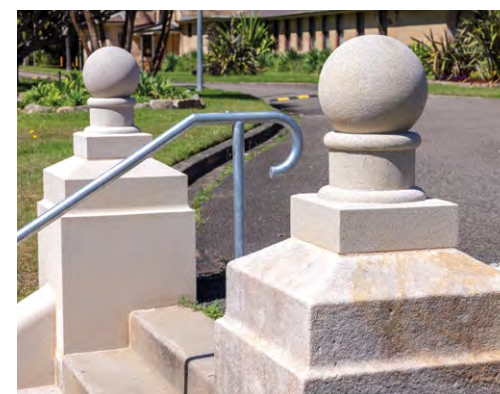
**Top:** Formal entrance following work

**Below:** Repairs to staircase

**Left:** Column carving details

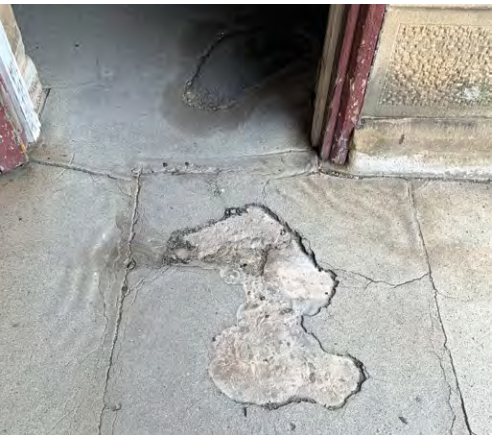
**Top:** Existing view of asphalt pathway around female wards at Callan Park, Kirkbride

**Below:** Asphalt deterioration in need of repair

Within the Kirkbride Complex, asphalt was used for external pedestrian paths and internal floors in utilitarian rooms. The original asphalt has deteriorated. The uneven, cracked, raised, and missing sections present a trip hazard. Previous patch repairs have also affected the longevity of the asphalt by introducing more joints as well as altering the original, intended visual appearance. The asphalt made was a very common mixture for the period, a gap graded sand mix. It was laid in all the under cover verandah paths. When originally laid this would have been a black pathway banded by sandstone kerbing and walls. The worn mellow grey surface that is now seen would originally have been a pitch black colour, significantly changing the aesthetic qualities and high lighting the perimeters of each wing of the hospital. The surface would have had a fine texture, but this has now been worn smooth.

The purpose of the asphalt strategy is to provide a Heritage Act 1977 approval for asphalt replacement like for like over a number of years without a site specific scope. This flexibility allows the Ministry of Health to repair asphalt in stages according to condition and priority when funding is available. It reduces approval red tape and promotes a more strategic approach to catch up maintenance and repairs.

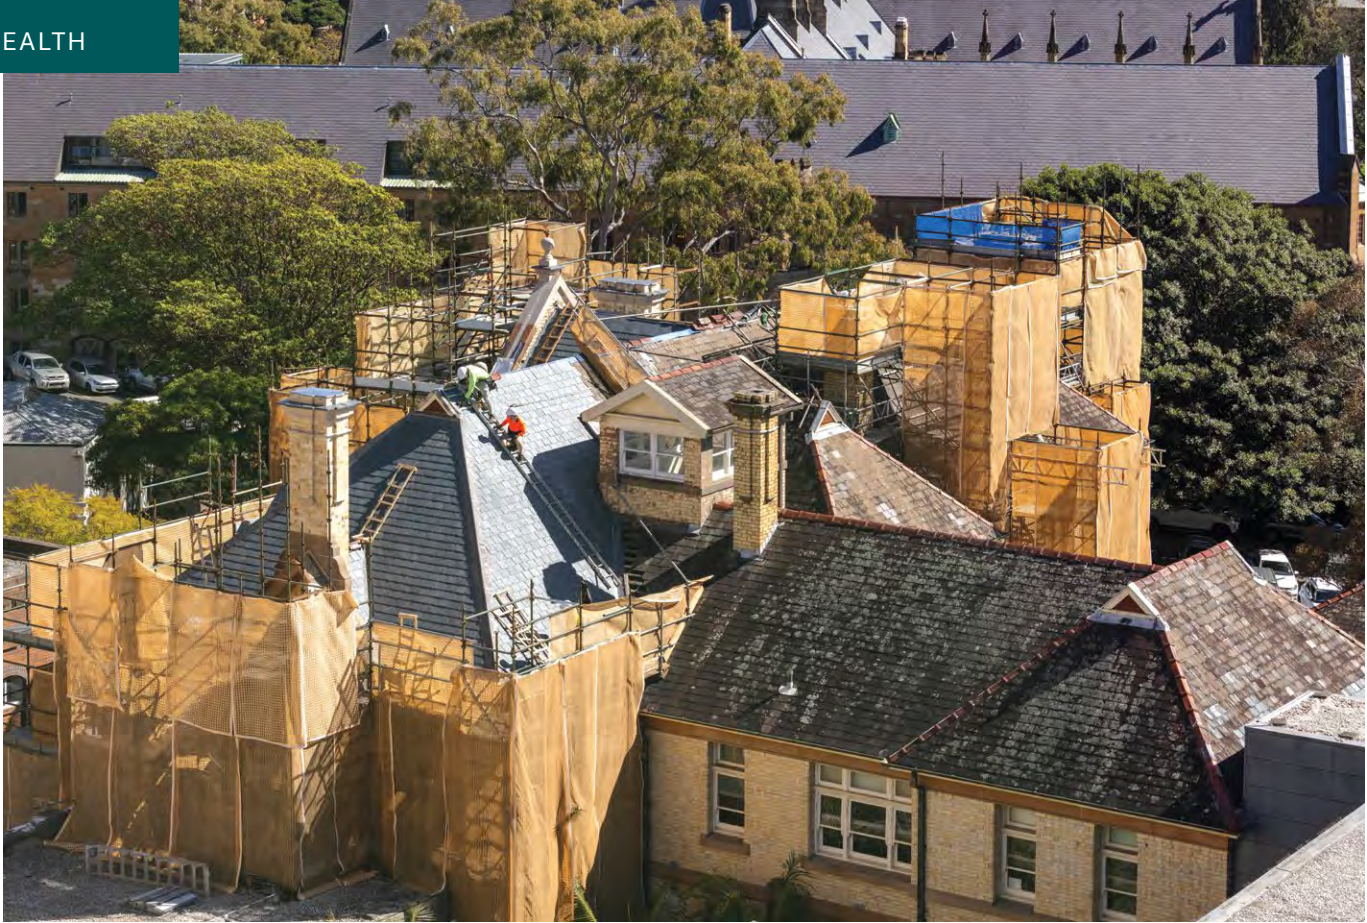
RPA KERRY PACKER EDUCATION CENTRE

Constructed of blonde face brickwork with sandstone detailing, gables, chimneys and slate roofing, the building has undergone gradual deterioration over time. A 2020 Condition Audit identified priority works to address risks associated with falling stone, corroded elements, water ingress and non-compliant seismic stability.

**Top:** Work underway to repair slate roof  
**Below:** Vent and decorative surround  
**Right:** Replacement carved detailing

The project is staged over multiple financial years and Stage 1 works included the replacement in full of the slate roofing and associated elements, stabilisation and repairs of chimneys, repairs to gables and replacement of sandstone, and lead flashings.

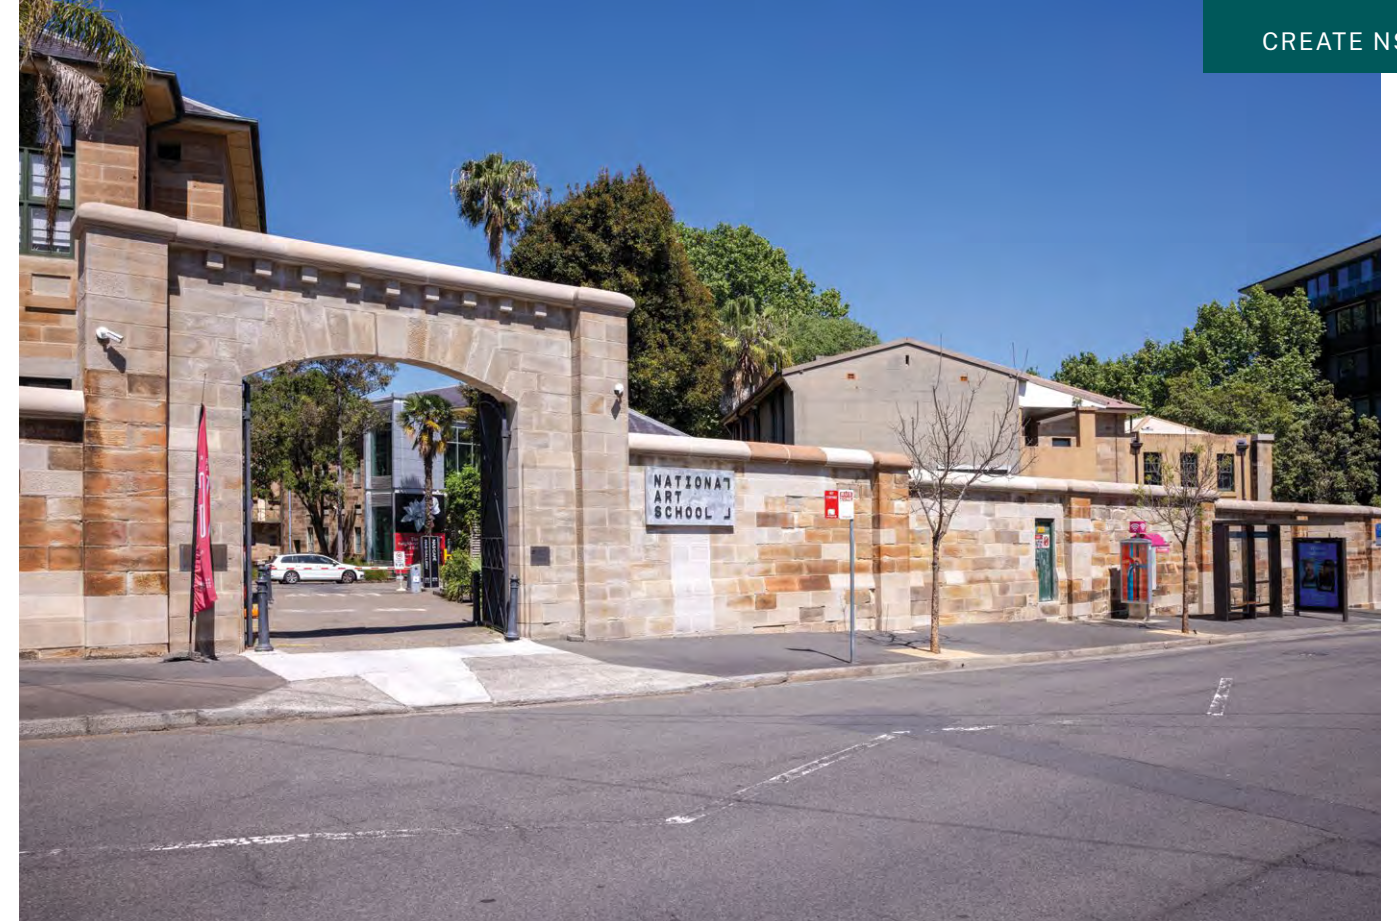
## NATIONAL ARTS SCHOOL BURTON STREET WALL

The purpose of the conservation works is to ensure the long-term conservation of this significant heritage, former gaol boundary wall, while retaining as much as possible of the original building fabric. Over time the condition of the sandstone has deteriorated in areas. Repair priorities to this wall are focused on public safety.

**Top:** Completed external conservation works.

**Below & Left:** Repaired sections of the Burton Street wall.

This financial year saw the conservation works begin on stage 1, including cleaning, replacement and repair of sandstone, as well as the repointing of mortar joints and the removal of metal fixings, and hard cement pointing.

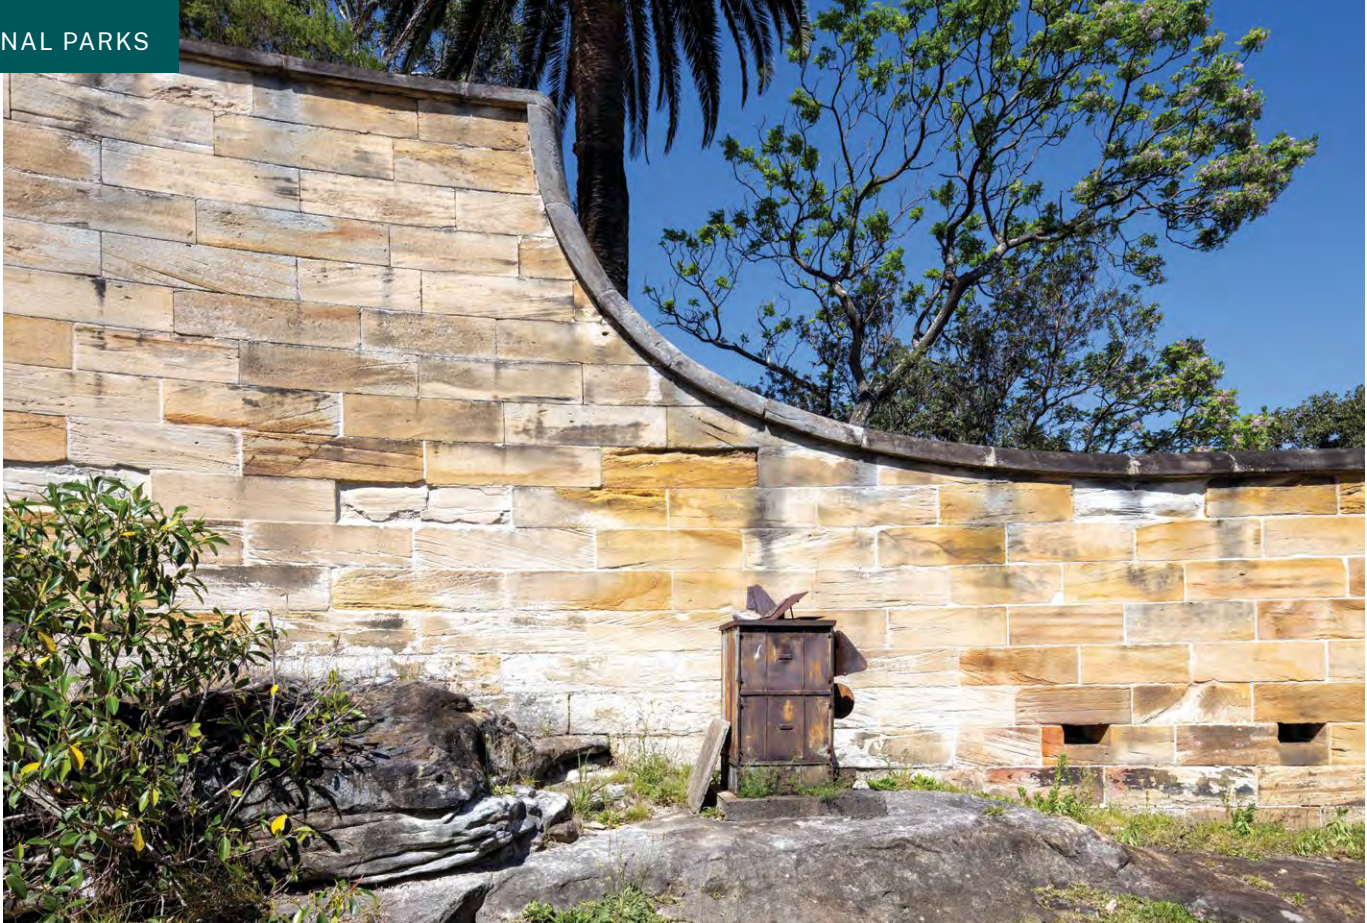
## GOAT ISLAND SENTRY WALL & BOX

The exposed marine environment, composition of the sandstone and previous cement repairs have led to the moderate to severe degradation of the stonework of the sentry box. This stonework has extensive, significant early colonial graffiti which influenced the approach to our proposed repairs. Every effort was made to retain blocks with significant graffiti using patch repairs to extend their lifespan and retain these elements.

**Top:** Fortified wall in need of sandstone repairs

**Below:** Early colonial graffiti will be conserved during future works

Previous works to the sentry box by the Minister’s Stonework program included replacement of the string course, introduction of a lead weathering and repointing.

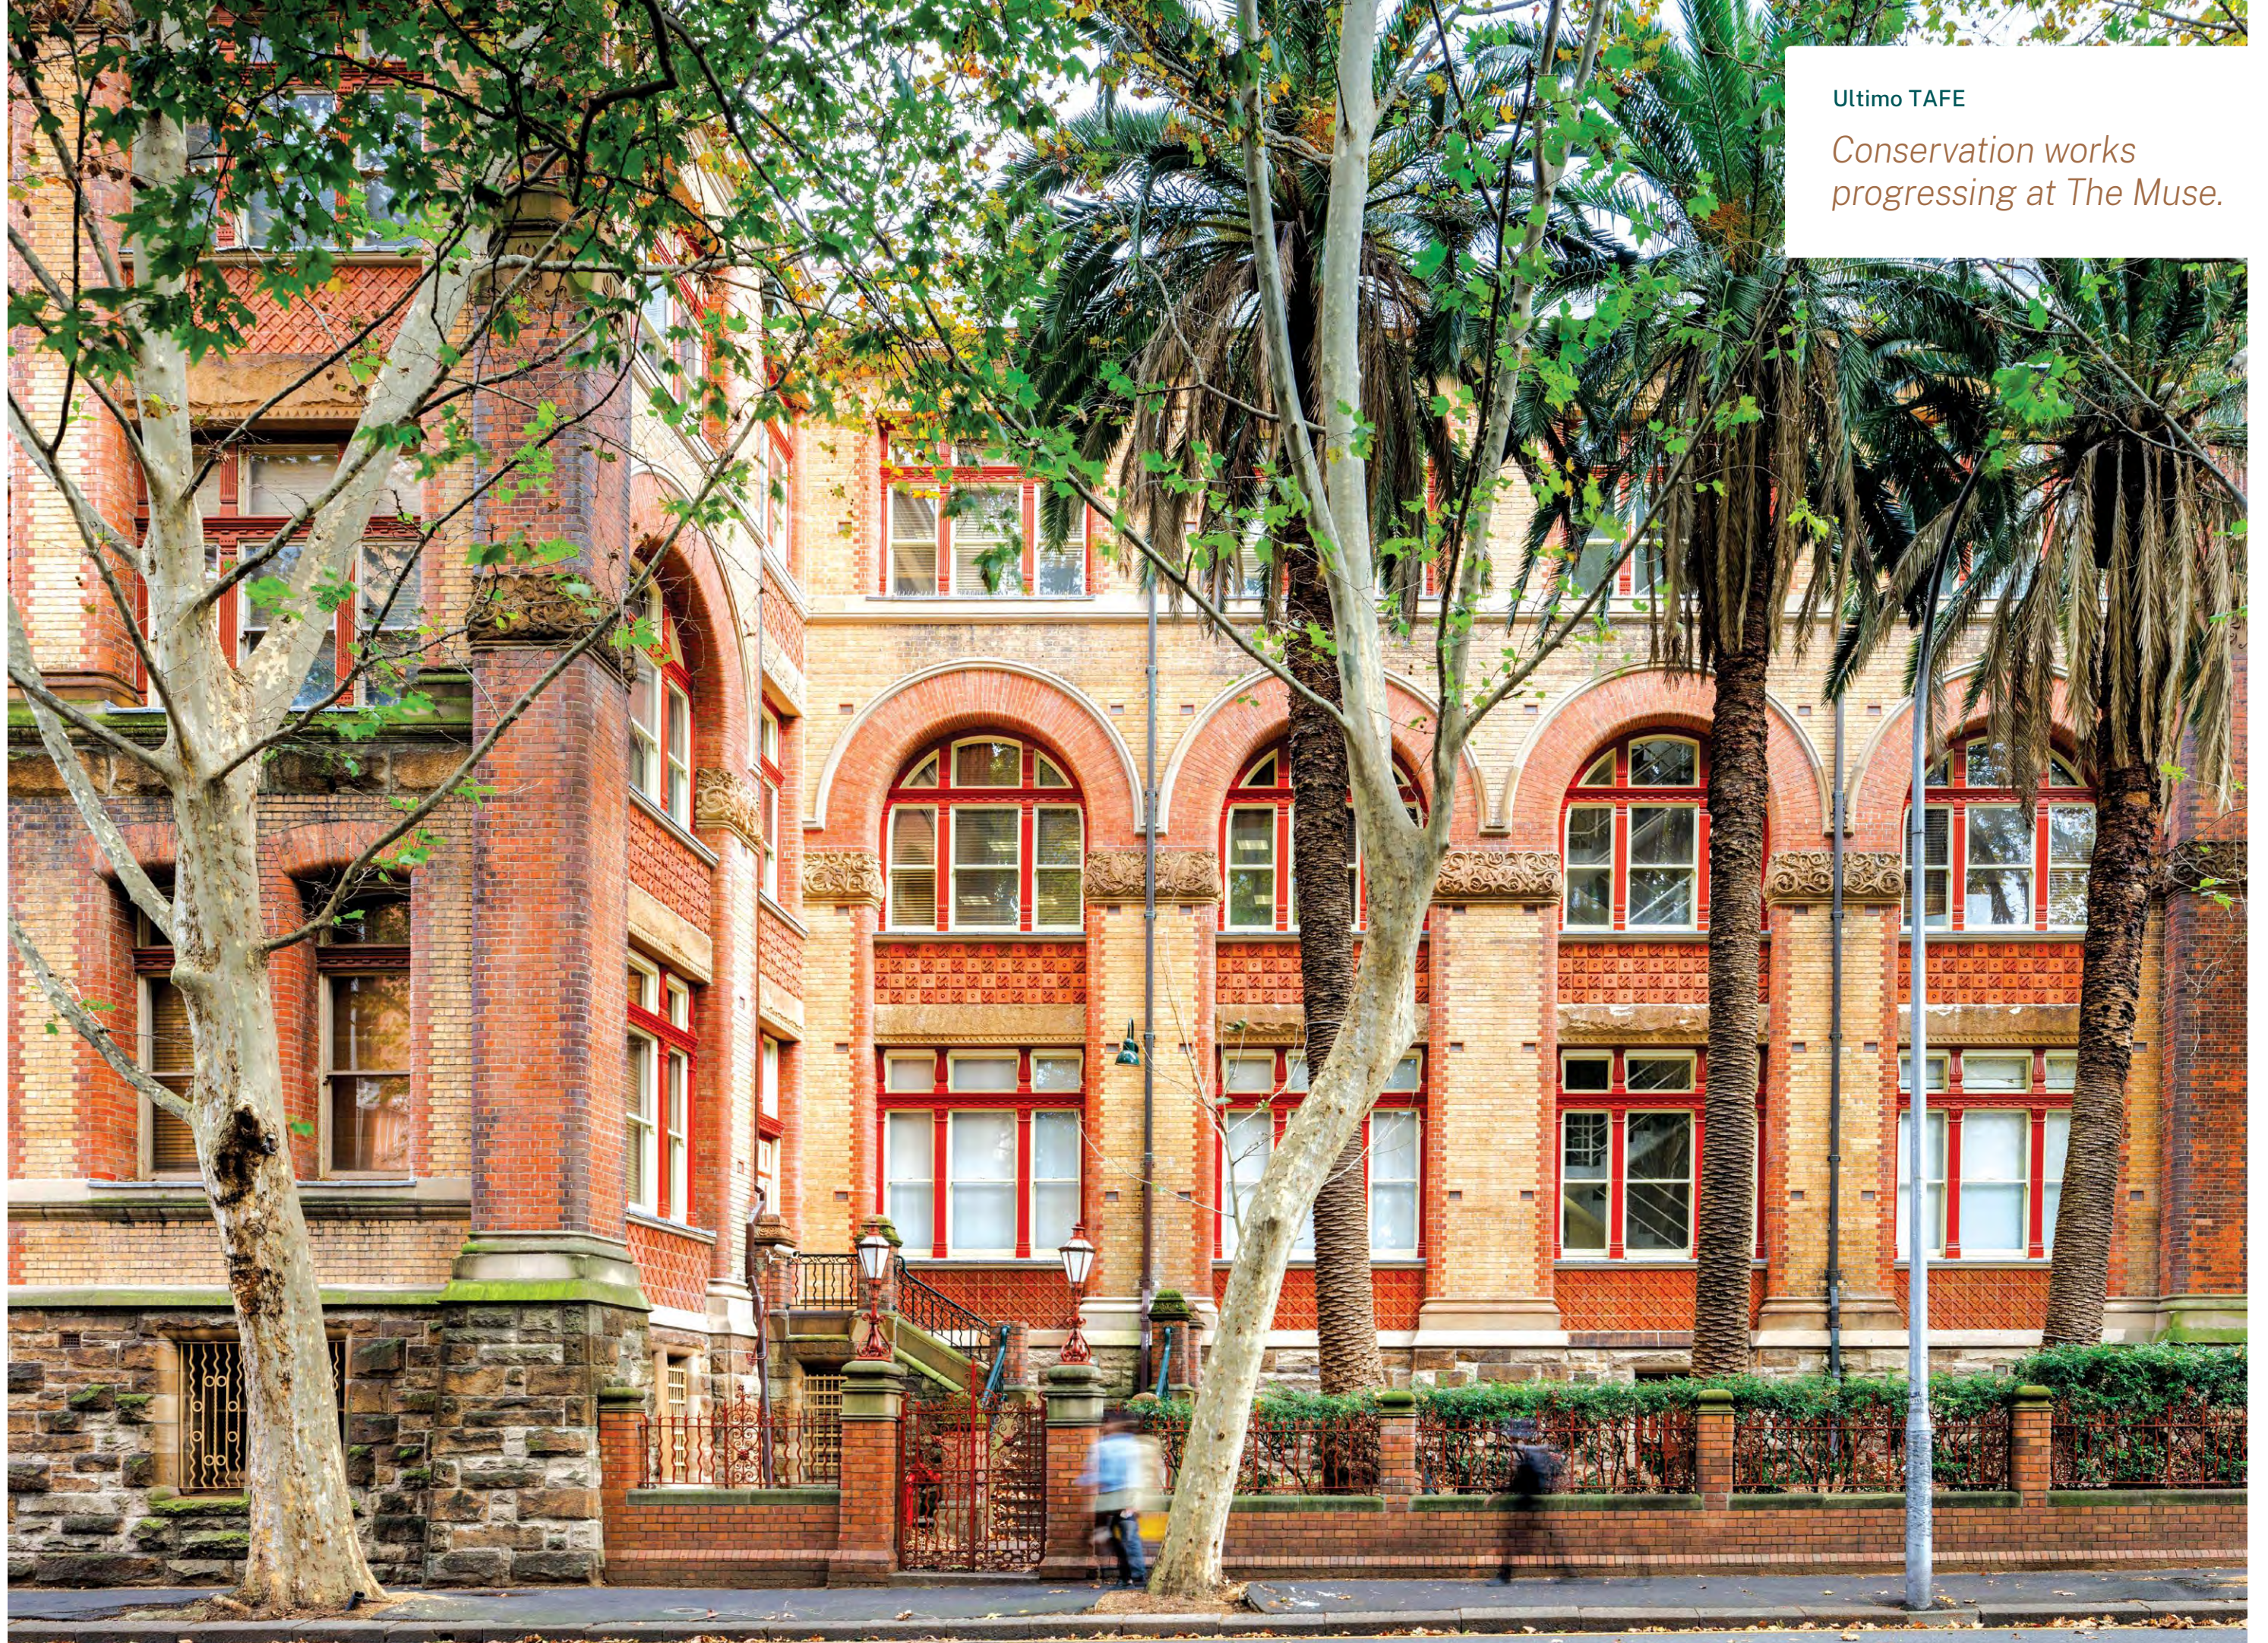
Public Works Heritage Team conduct a condition assessment of the Penitentiary at Port Arthur, Tasmania/Lutruwita.

**Port Arthur** Historic Sites Management Authority (PAHSMA) engaged the Program's experts within NSW Public Works, to undertake a structural and fabric condition inspection of the Penitentiary, Bakehouse, and Watchmen's Quarters.
