# 21-22

ANNUAL ACHIEVEMENTS

MINISTER'S  
STONEMASONRY  
PROGRAM

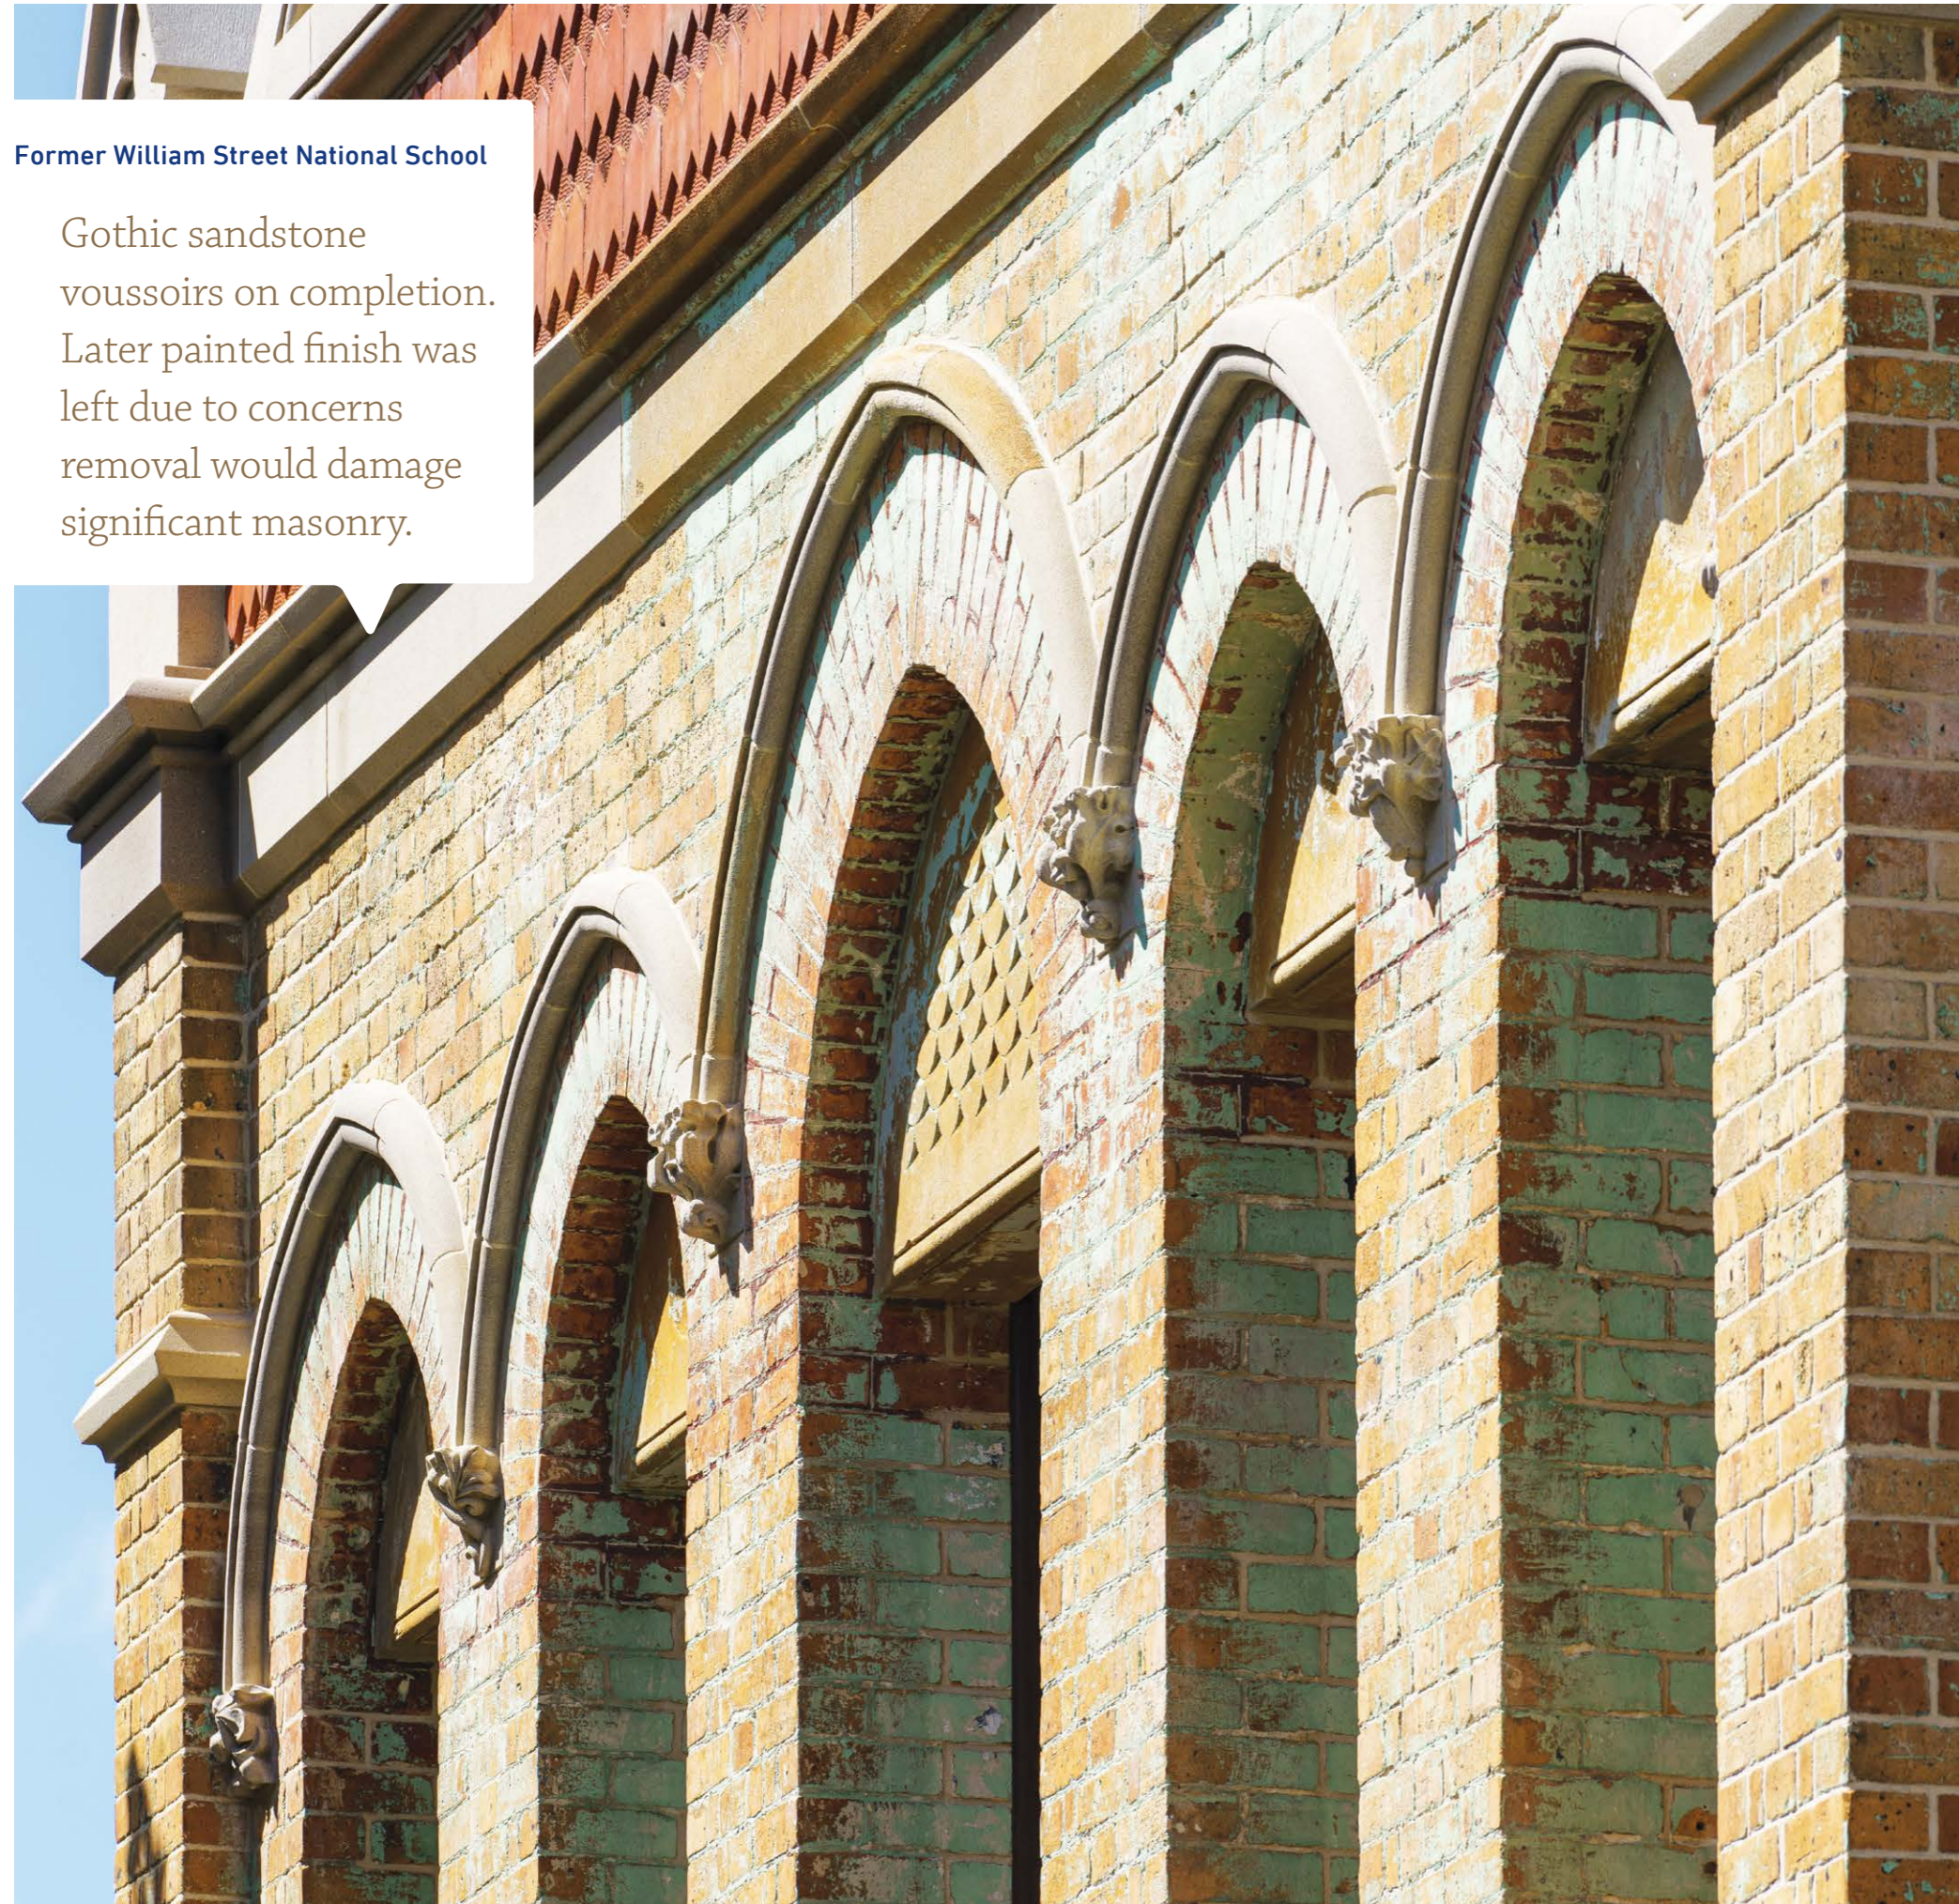
**Former William Street National School**

Gothic sandstone voussoirs on completion. Later painted finish was left due to concerns removal would damage significant masonry.

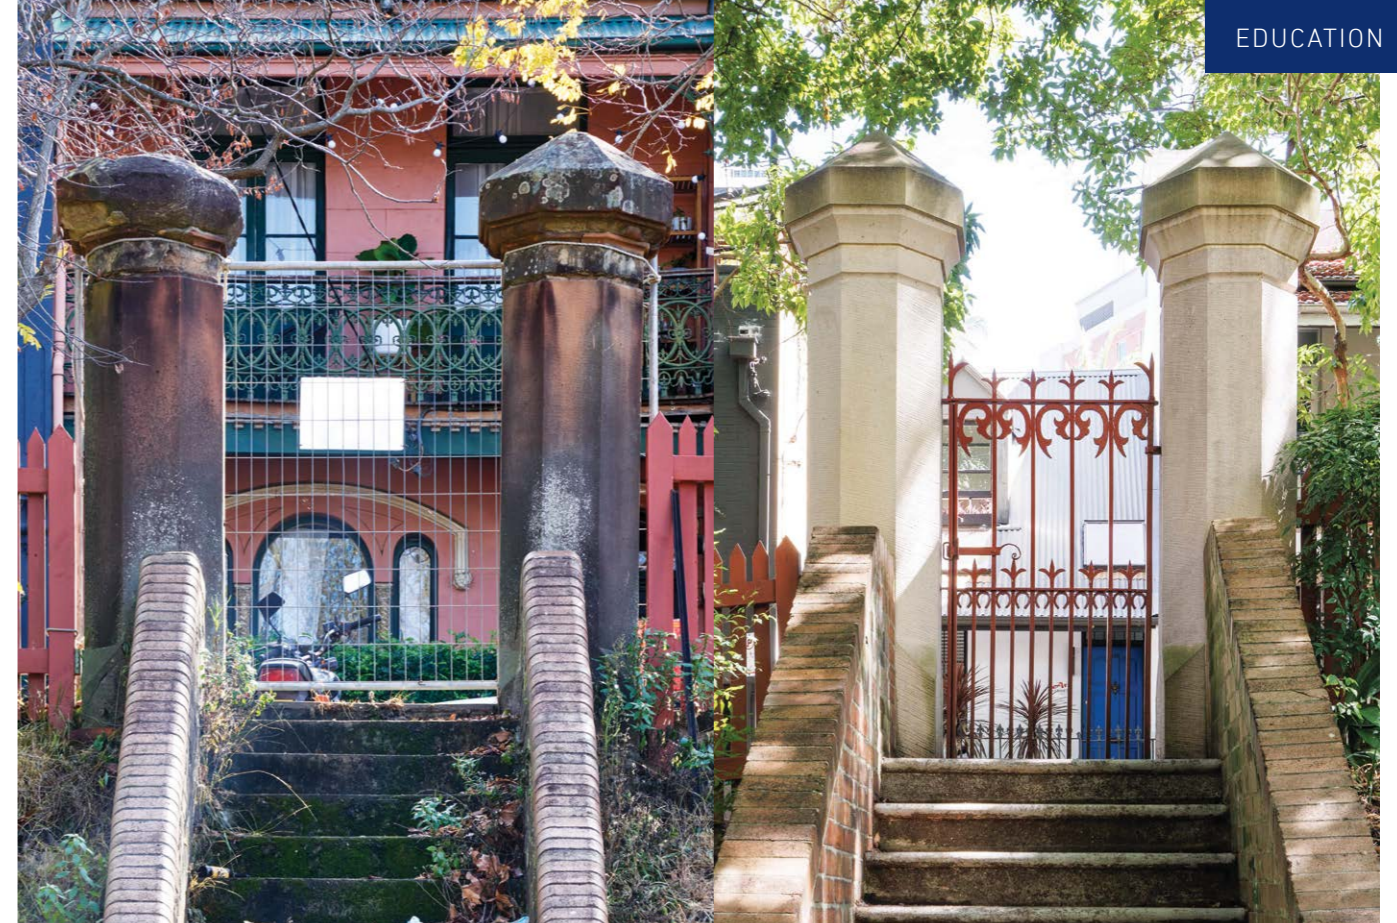
## DARLINGHURST PUBLIC SCHOOL

**Top image:** Before and after images of sandstone gate piers to Womerah Avenue

**Lower image:** Repaired metal balustrade to main entrance

The project began as a simple sandstone gate pier repair (stone delamination was a safety risk) and conservation project. The inter-connected elements of the gates and stairs increased the scope and original intent to encompass all aspects of the three original entrances to Darlinghurst Public School.

Conservation works were undertaken by a team of heritage architects and heritage trades specialists and include replacement of deteriorated sandstone gate piers, repairs to the metal gates, repointing, repairs to original metal stair balustrade, repairs to broken and cracked stairs and thresholds. The height of the balustrade on the main entrance bridge was increased and a grab rail installed to the separate stairs from Womerah Avenue.

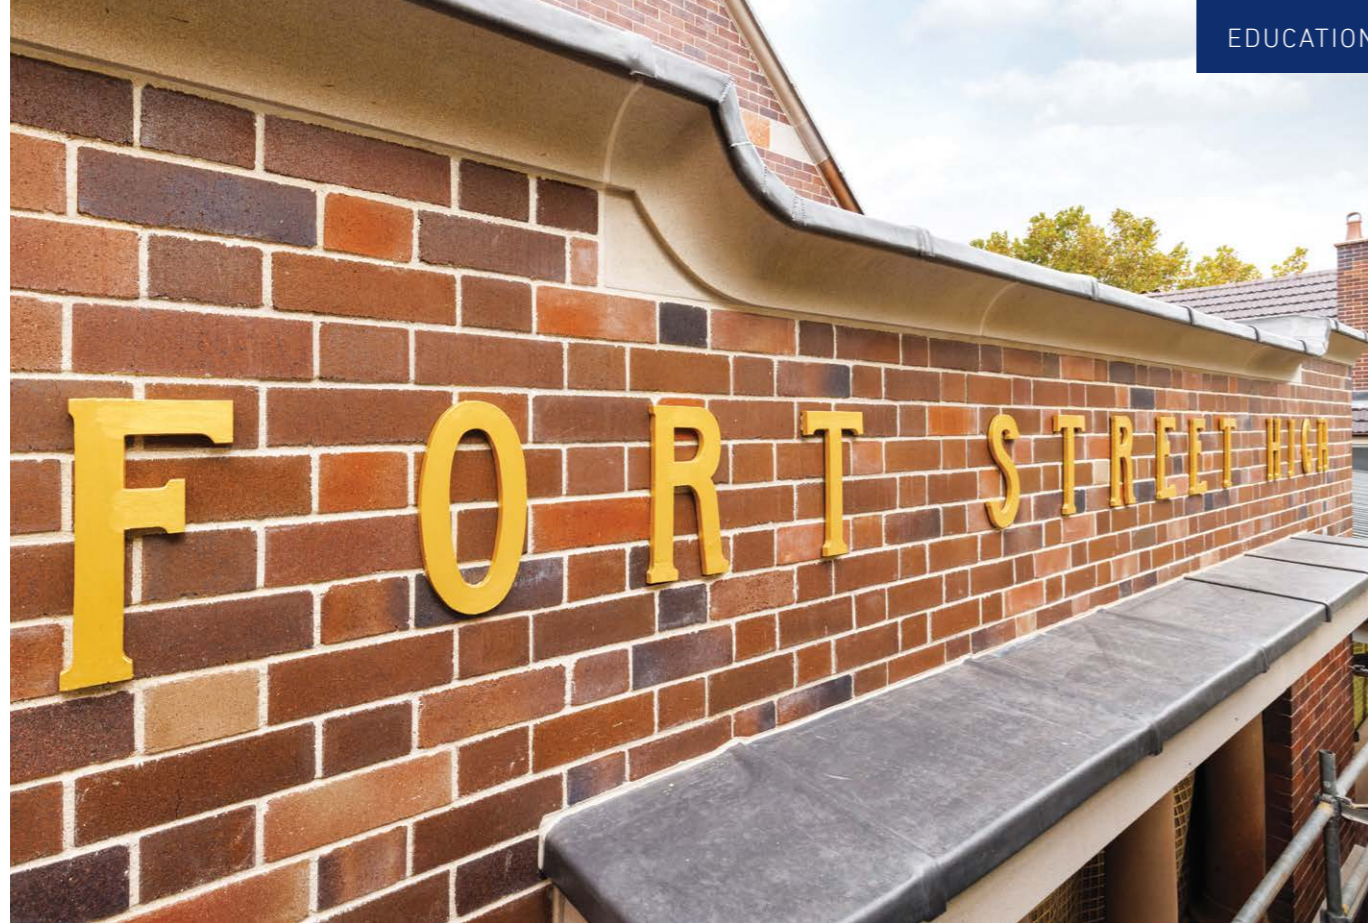
## FORT STREET HIGH SCHOOL

**Top image:** Lead weathering was introduced to protect and shed water away from significant fabric below.

**Lower image:** Desalination works to sandstone

Stage 1 works included structural stabilisation of the two gables and chimney No1. Traditional lead flashings to the gables and chimney No1 replaced defective roof flashings. Replacement of deteriorated sandstone commenced and protective lead weatherings were installed over the stone gable copings.

Additional works included stone and brickwork repointing, stone desalination and patching. Deteriorated copper window awning roofs were replaced in lead to match the original detailing.

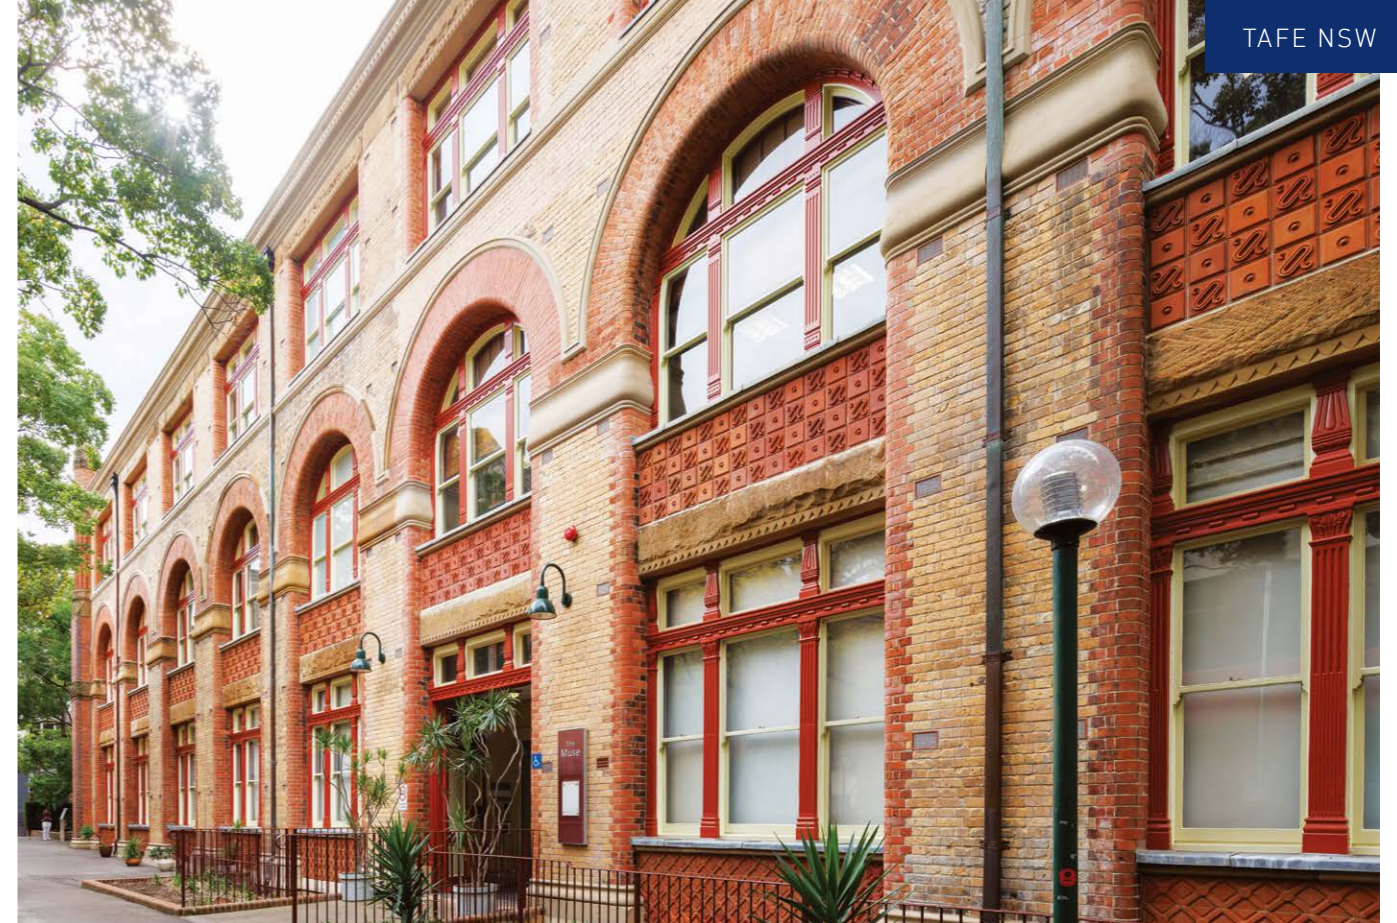
## ULTIMO TAFE

**Top image:** Completed external conservation works

Roofing works were completed in the 20-21 financial year. Stage 2 works, this financial year, included synthetic stone repairs to cracked/damaged stone retained in situ, repair of stone lintels, repointing of sandstone and brick joints, re-grout terracotta tiles, repairs to highly weathered timber windows and doors, external cleaning to remove biological growth, bird droppings and dirt, provide new mesh to wall vents, and installation of bird proofing.

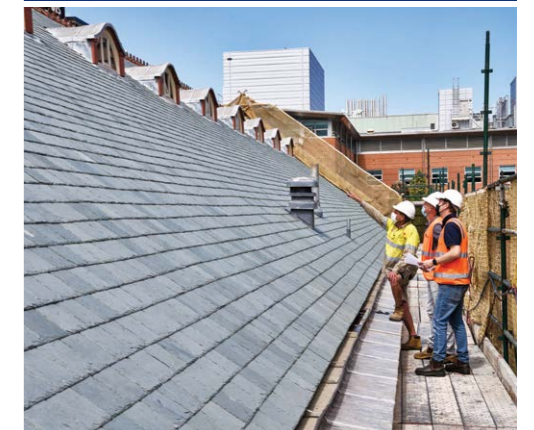
**Lower image:** NSW Public Works staff undertaking technical inspections during construction

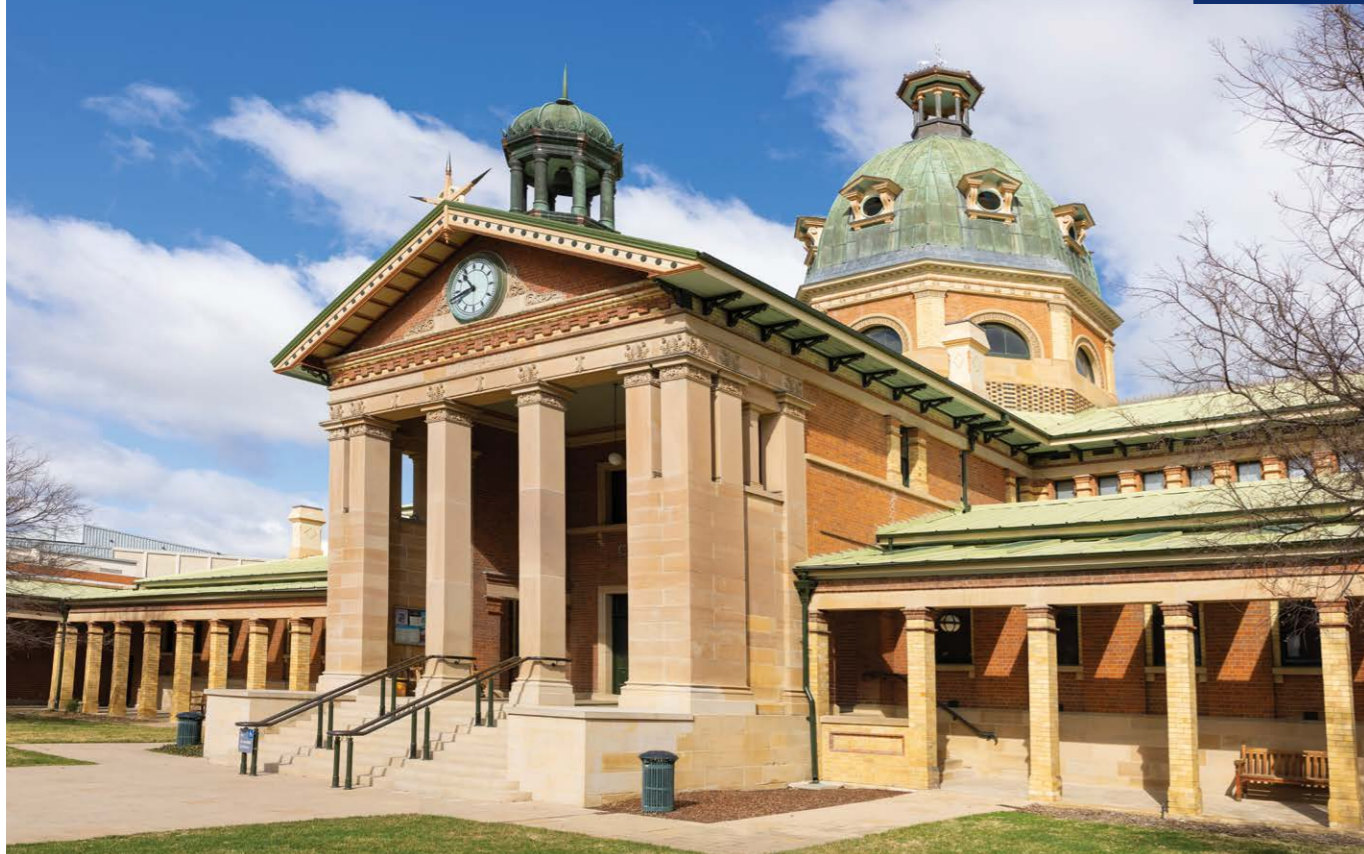
## BATHURST COURTHOUSE & CLOCK REPAIR

**Top image:** Completed external conservation works

**Lower image:** A new cornice stone being lifted into place

The objective of the project was to undertake catch-up maintenance to best practice conservation standards and provide quality long term repair solutions (60+ yrs). The conservation approach was to replace 'like for like' where possible, record all interventions and retain as much of the original fabric as possible. Historical research was undertaken to ensure the reconstruction of missing details, such as the tri-spoke finial, was accurate and based on documentary evidence. Likewise, a paint colour analysis was carried out to provide a historically accurate colour scheme.

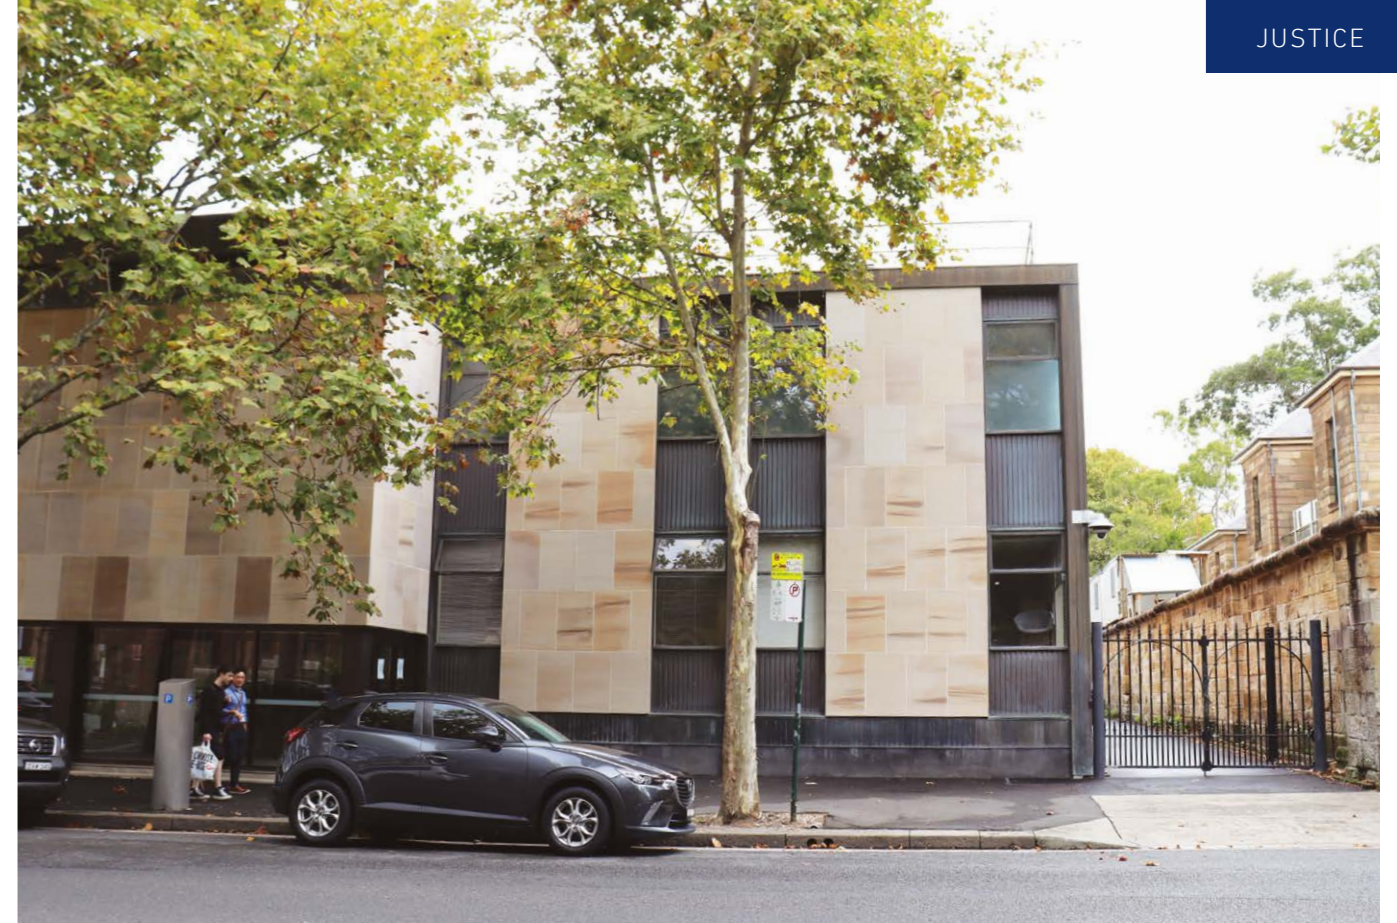
## DARLINGHURST COURTHOUSE

- natural weakness of the sandstone due to the panels being placed perpendicular to the natural bedding
- inadequate fixing to the masonry substrate.
- exfoliation of the surface of the stone likely from the application of a sealant and/or inappropriate high-pressure water cleaning.
- misalignment of the sandstone panels due to thermal expansion.

**Top image:** Completed external conservation works

**Lower image:** Delaminating sandstone panels were replaced and a new more secure fixing system was introduced by the Heritage structural engineer

- temporary fixing of cracked panels until funding for the works was obtained
- replacement of deteriorated and failed sandstone panels like for like
- a new, more secure fixing system was developed by project engineer
- 100% repointing of stone joints
- application of biocide to prevent biological growth.

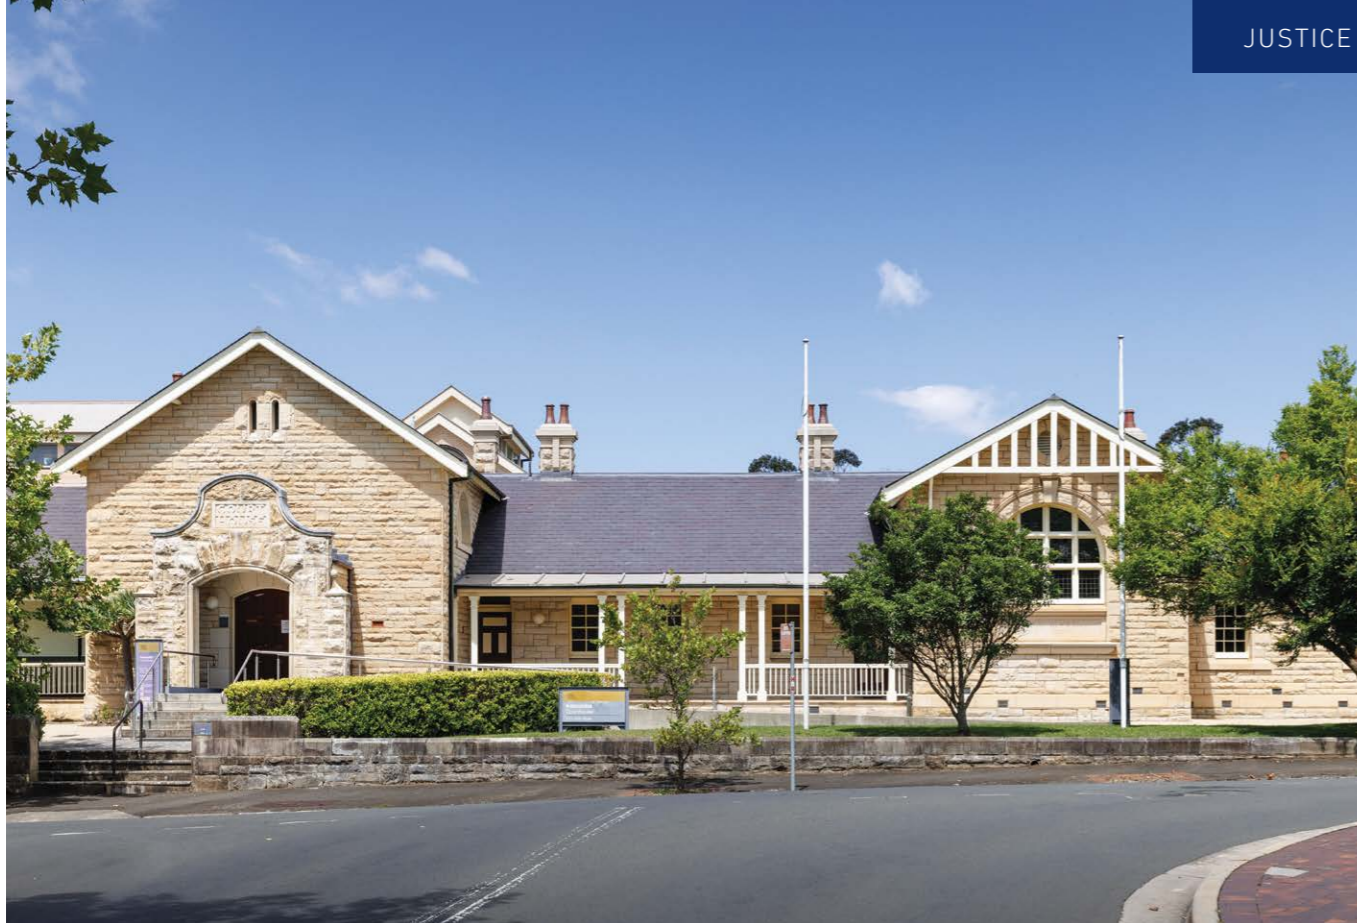
## KATOOMBA COURTHOUSE

**Top image:** Completed external conservation works

**Lower image:** Full slate roof replacement and installation of new lead weathering to front portico

The conservation works to the Katoomba Courthouse façades began in the financial year 2020 and were completed in 2021/22. The work included facade cleaning, stone replacement, the addition of lead weatherings, repointing of the unusual ribbon pointing, repair of the lead light feature window, timber repairs and repainting. The works also included the strengthening and stabilisation of the tall slender chimneys, restraint of the gables and front portico feature.

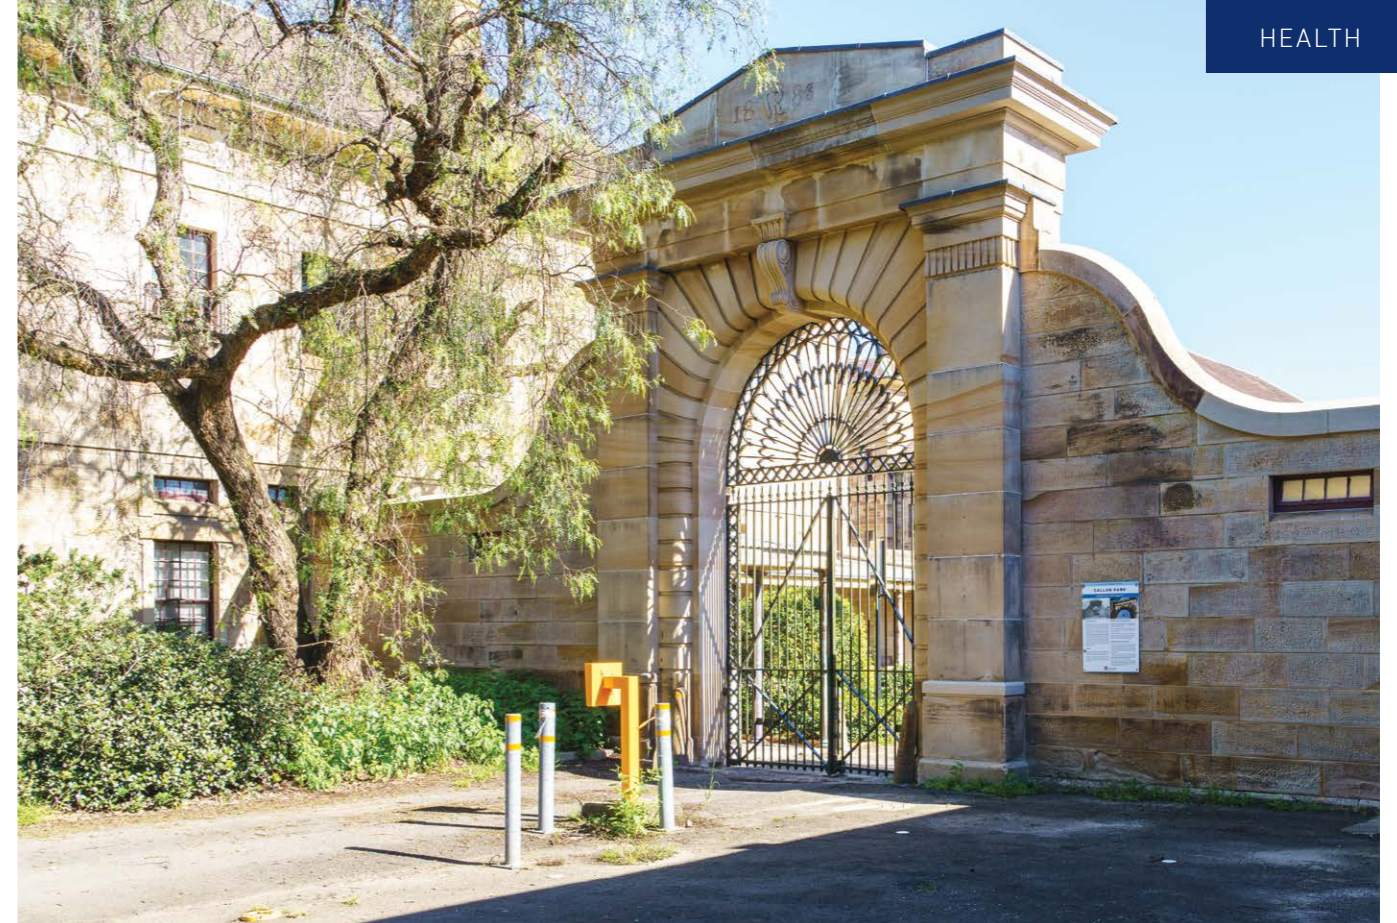
## CALLAN PARK SOUTH GATE - STAGE 2

**Top image:** Completed external conservation works

**Lower image:** Removal of deteriorated sandstone ready for indenting of new stone

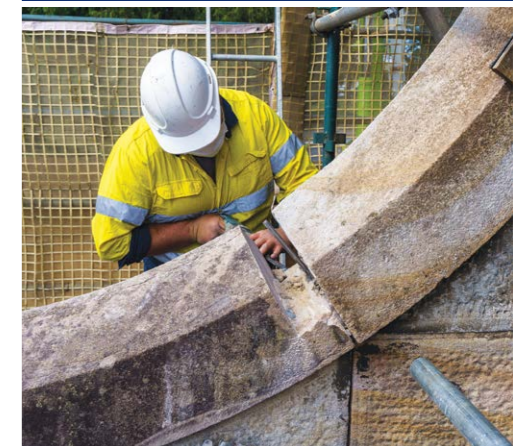
Cracks were visible from ground level along the upper sandstone moulding which could potentially dislodge without warning causing injury.

Conservation works, to the entrance gates, including repair of deteriorated, damaged stone and offsite repair and re painting of the original metal gates. The primary purpose of these works was to conserve as much original fabric as possible and safeguard the significance of the gates for future generations by improving their condition, function and setting. The Ministers Stonework team worked with contractors who improved the electronic functioning of the gates whilst minimising physical and visual impacts posed by remote operation.

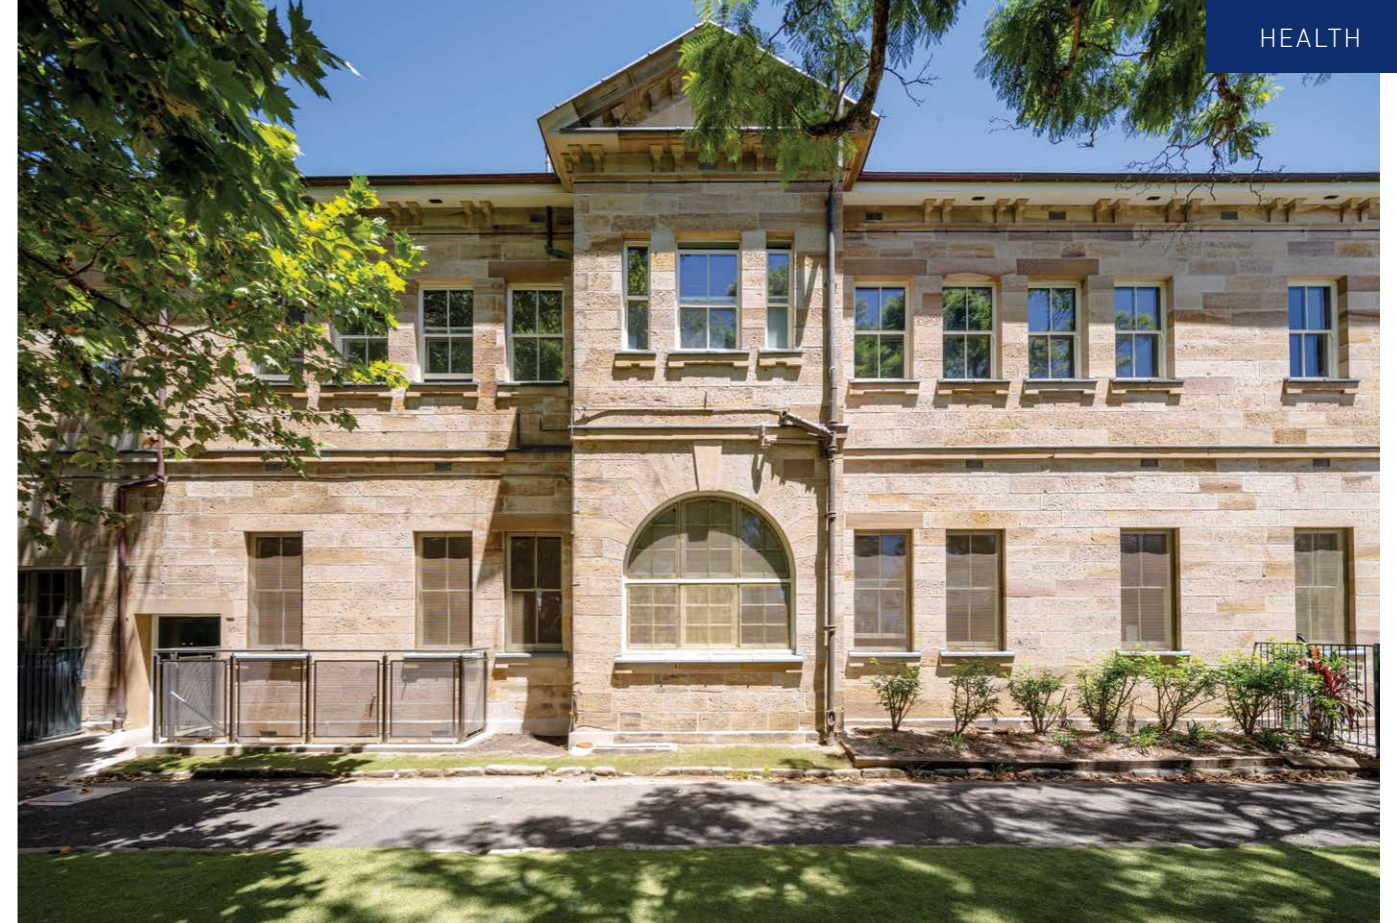
## GLADESVILLE HOSPITAL B30

**Top image:** Completed external conservation works

**Lower image:** Open, missing joints in the pediment caused water and salt damage to the significant stonework

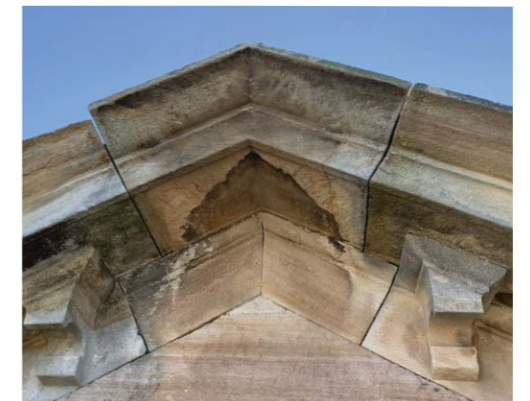
After being installed almost 150 years ago the condition of much of the high-level exposed sandstone on Building 30 had deteriorated and reached the end of its life. The stone also posed a safety risk and was no longer protecting the stone and other building elements below.

The works included replacement of weathered overhanging stonework at risk of failing, repointing, cleaning, desalination, biocide and patch repairs on all stonework, repairs and painting to the timber eaves and windows and slate roof replacement.

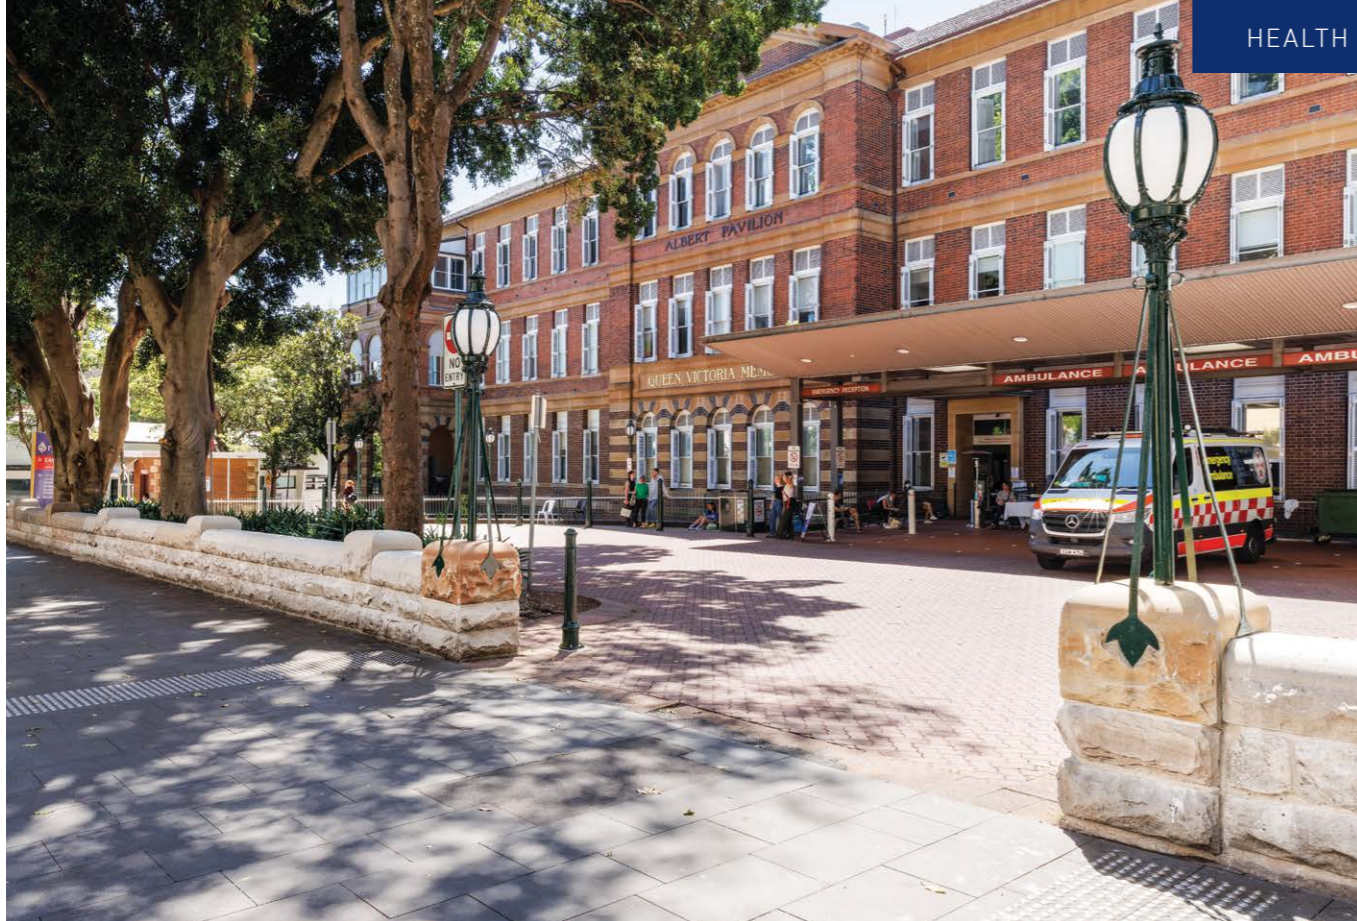
## ROYAL PRINCE ALFRED HOSPITAL MISSENDEN ROAD

**Top image:** Ambulance bay entrance with restored lamp pillars

**Lower image:** View of completed wall along Missenden Road

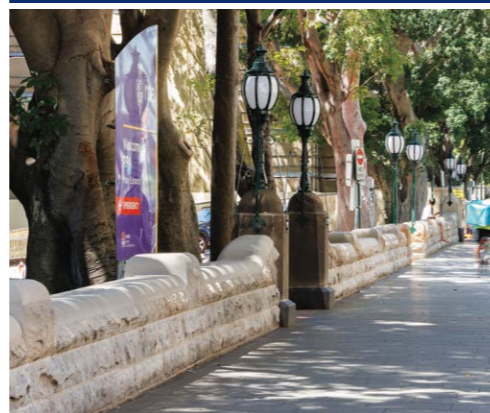
The stone units of the wall were in poor condition with significant cracking and extensive cement patch repairs. Majority of the coping stones and 3 piers were replaced. Additional works included full cleaning, repointing, synthetic stone repairs and biological treatments.

Conservation works also included weld repairs, corrosion removal, protective treatment and repainting to 11 lamp pillars and associated straps.

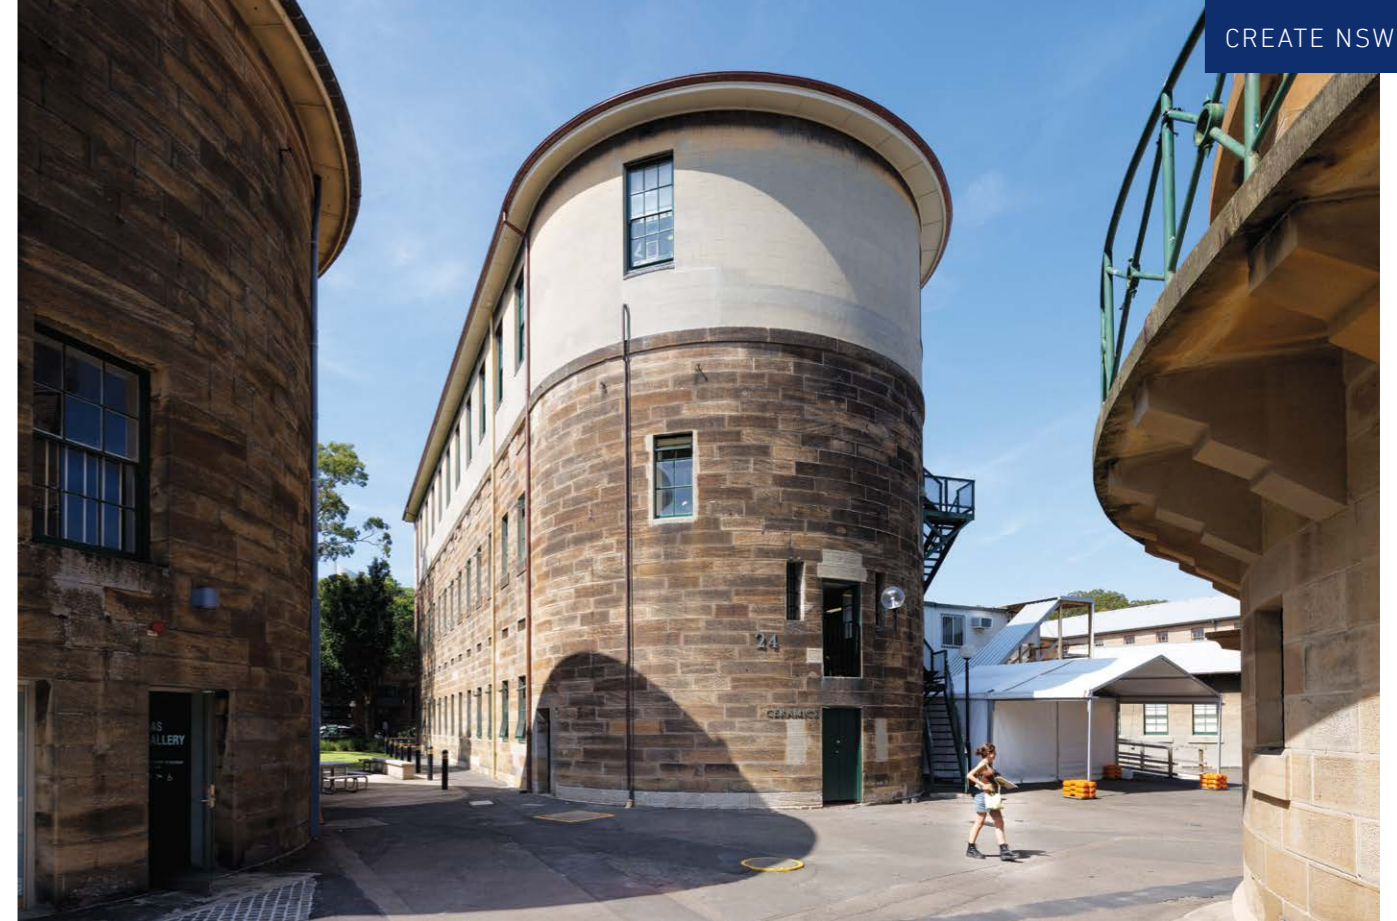
## NATIONAL ART SCHOOL BUILDING 24

**Top image:** Completed external conservation works

**Lower image:** Works completed include; stone cleaning, new copper rainwater goods, new vermin mesh to vents and render repair to the 1929 addition

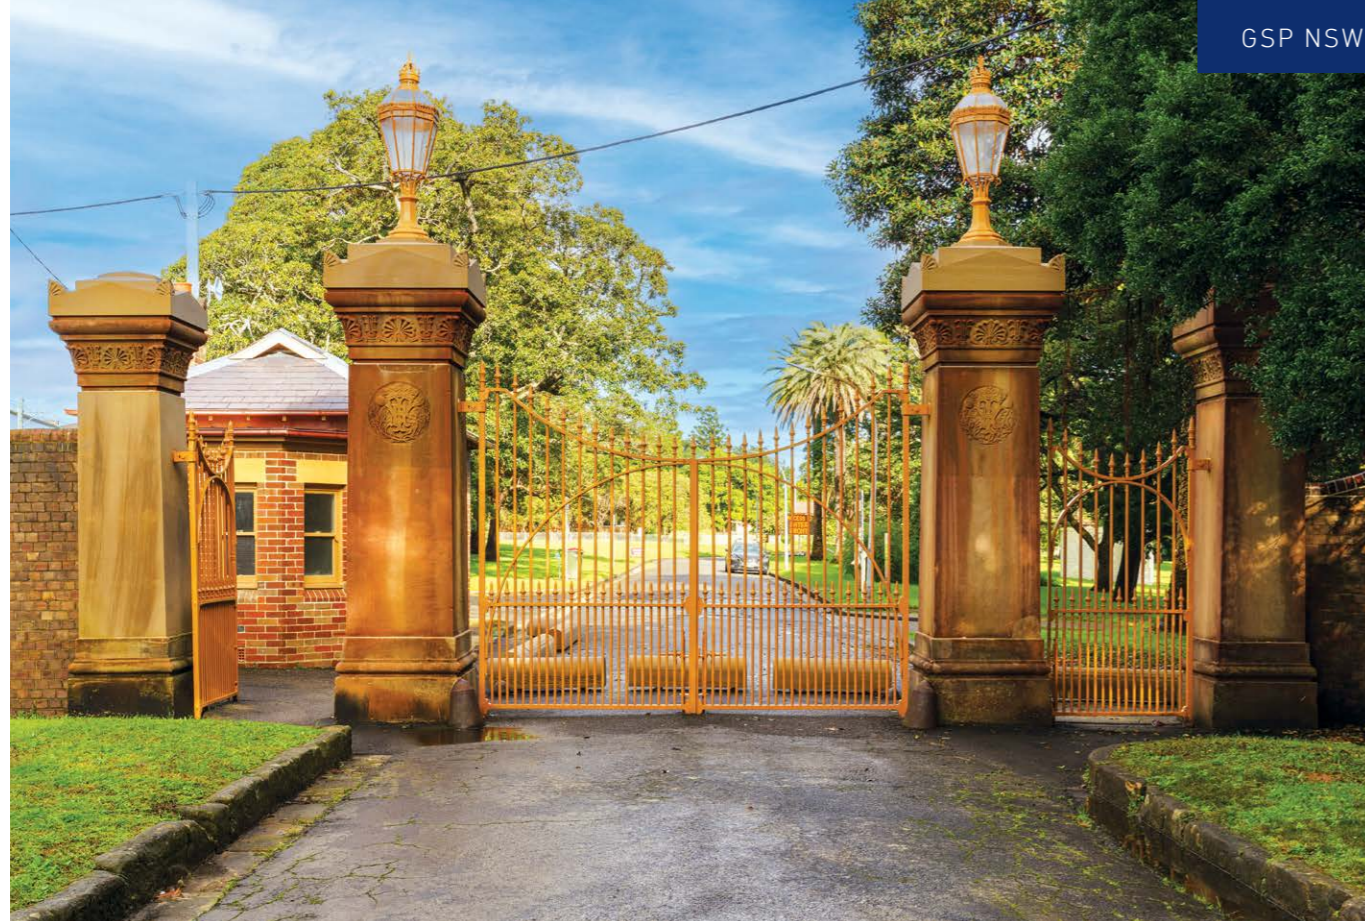
## CALLAN PARK GATES & GUARDHOUSE

**Top image:** Completed conservation works

**Lower image:** Completed conservation works to lanterns

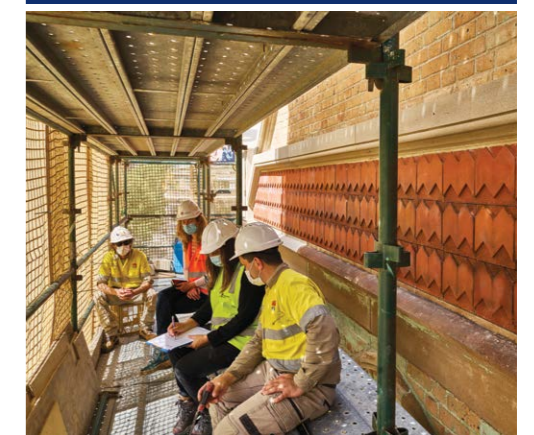
## FORMER WILLIAM ST NATIONAL SCHOOL BUILDING

**Top Image:** Completed external conservation works

**Lower image:** Project team during on site technical inspection

The aim of the works was to provide durable conservation solutions. The scope of works included replacement and patching of deteriorated stone, removal of paint from stone sills, replacement of the Colourbond roof with galvanised steel sheeting and reinstatement of the original colour scheme.

The work involved the replacement of heavily deteriorated sandstone boss stones to the hood moulds. Due to the deteriorated condition the exact design of the moulds could not be seen and replicated. The conservation approach to these elements was therefore to create new stones in the style of those that had deteriorated, thus allowing the masons to contribute to the continuous and layered history of the building with their own artistic touches.

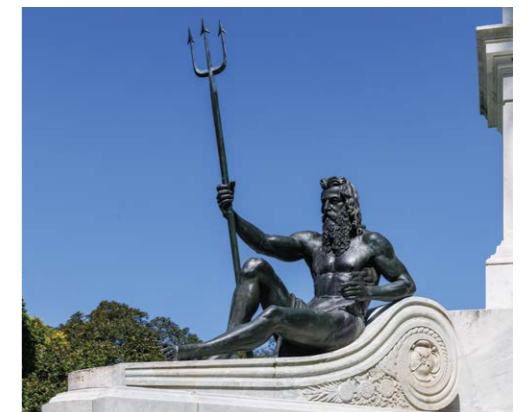
## GOVERNOR PHILLIP FOUNTAIN

Over the years the bronze statues had developed green and black surface corrosion, and the marble had extensive, deeply engrained green staining caused by copper corrosion with water run-off from the bronze (copper alloy) sculptures. The last conservation works to the bronze works was carried out in 2000, which did not satisfactorily address the green copper staining in the marble.

**Left image:** Bronze sculpture of Cyclops (Mining)

**Top image:** Completed conservation works

A specialist conservator was commissioned to undertake conservation works on the fountain which included conservation works of all thirteen bronze elements, waterproofing of the marble basins, repointing and trialling of marble cleaning techniques to remove the green copper staining.

Public Works provided recommendations for the treatment of the staining to the white marble based on international research on a highly effective method of cleaning copper-stained calcareous stone. A recent internationally developed poultice mix was used to draw out the green copper staining without the look of being over-cleaned. The poultice delivered fantastic results and has removed almost all the staining, resulting in a clean marble finish while retaining the patina of the historic fabric.
