# 21-22

ANNUAL ACHIEVEMENTS

MINISTER'S  
STONEMASONRY  
PROGRAM

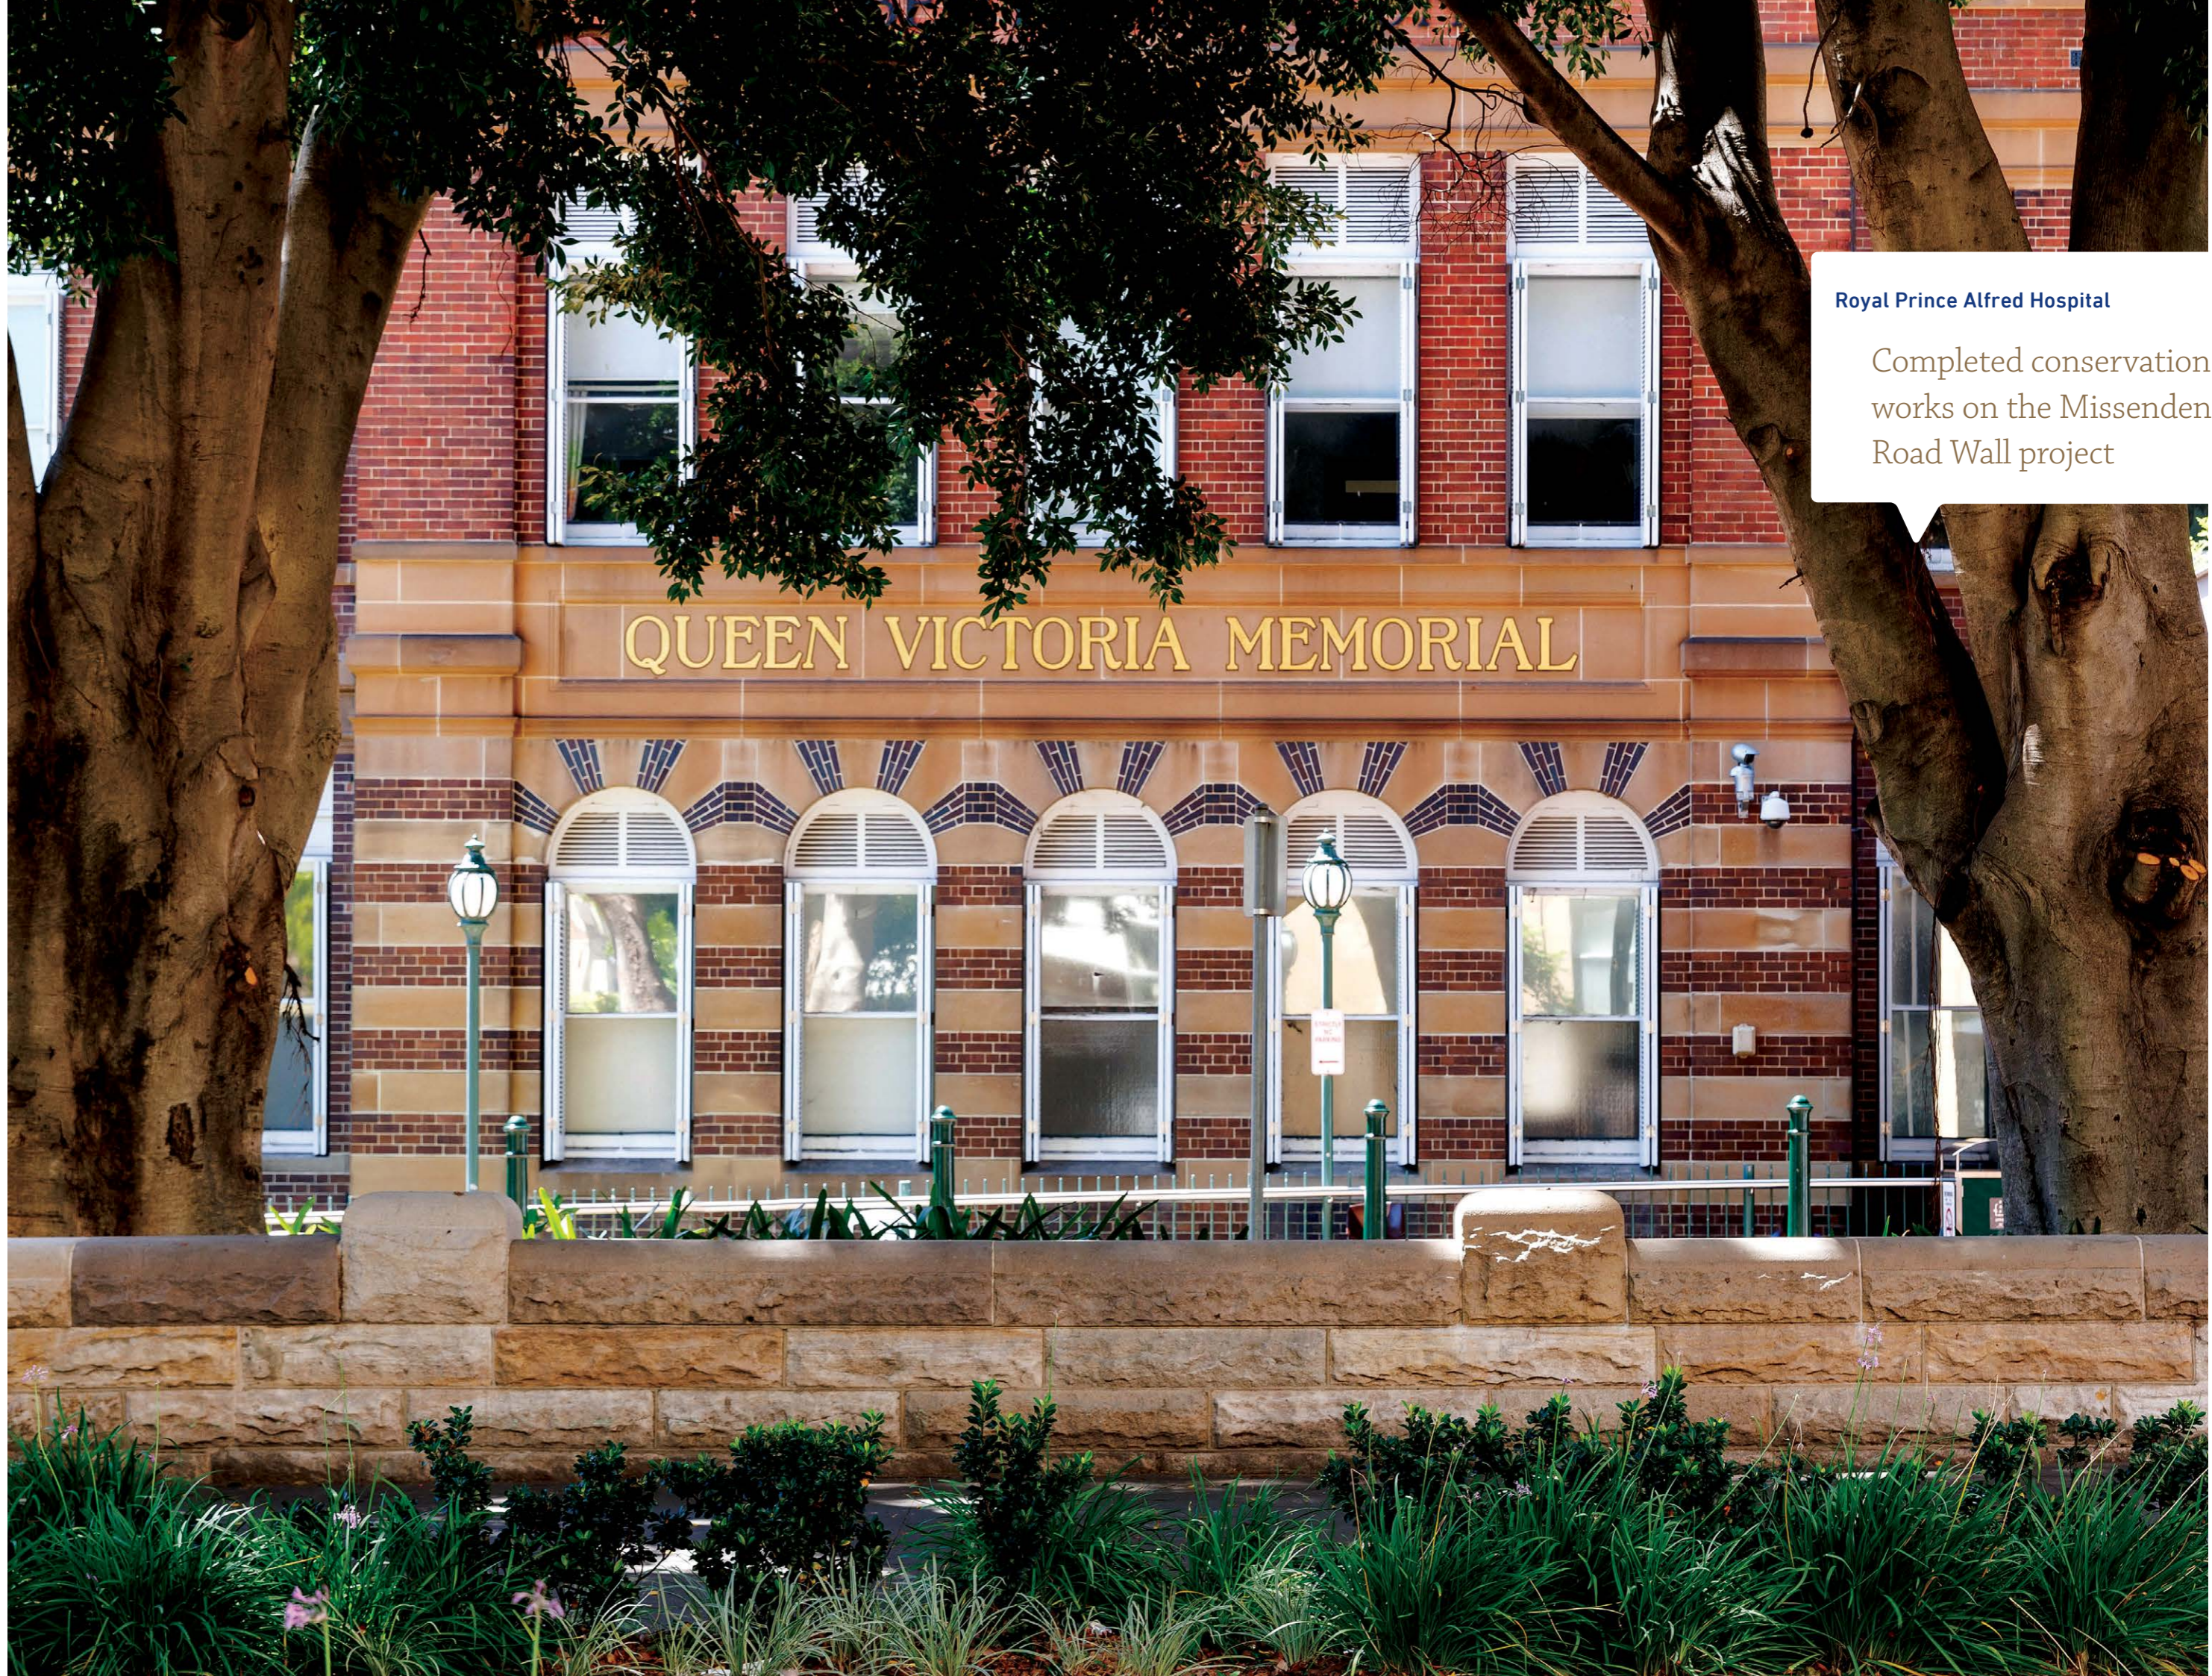
Royal Prince Alfred Hospital

Completed conservation works on the Missenden Road Wall project
