PARTNERSHIP PROJECTS

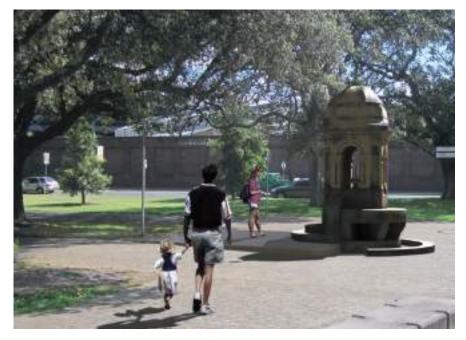
The Comrie Memorial Fountain was constructed as a bequest from the will of Mrs Sophia Louisa Comrie "for the use of Man and Beast". The fountain was first opened at St James Road Queens Square in 1904, however due to increasing traffic in the vicinity the fountain was relocated to Driver Avenue adjacent to Moore Park in 1934. With the construction of the Eastern Distributor in 1995 the fountain was dismantled and stored in the Centennial Parklands' Depot.

In 2010 the decision was announced to reconstruct the fountain at Federation Way, Centennial Park. However before site works could commence a number of modifications

were required to meet current health regulations. Originally a single source of water served the fountain. In order to meet current health regulations four sources of water were required, each with their own connection to the sewer.

A number of missing elements were also reinstated including eight red granite columns and a decorative bronze bowl. These items have been replaced to match their original detail. Discreet lighting has also been introduced into the reconstruction.

Site works commenced in April 2011 with an expected opening date in October 2011.

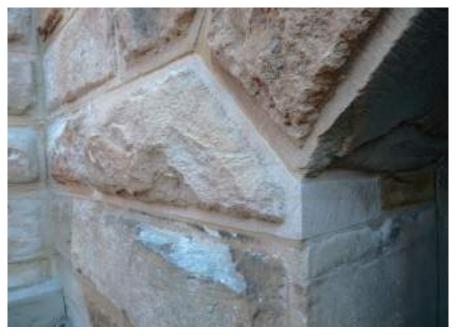
Coogee Public School was established in 1876 and has historical significance as one of the schools established under the Council of Education and as the first school to be provided with 'pavilion' classrooms. The school is also of aesthetic value as an example of the work of the Government Architect George Allen Mansfield.

2010/11 saw the completion of minor works to the arch over the entrance to the canteen. The arch stone was replaced and repointing was undertaken to secure the safety of the arch. The surrounding stones were desalinate washed to remove salts.

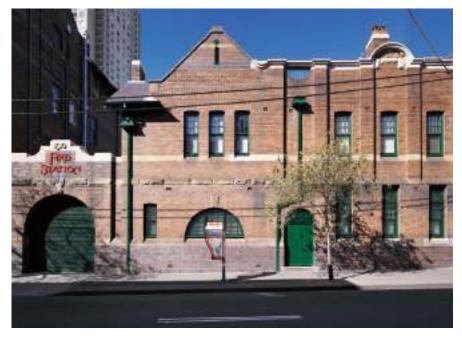
many years. In partnership, eight stages have been completed including Work Areas C & F in 2003/04, Work Areas D, E & F in 2005/06, Work Areas P, B & O in 2006/07 and Work Area A in 2007/08. In 2009/10 stone was processed for Work Area S.

In 2010/11, Work Area S was carried out as a jointly funded project. Works included stone replacement, lead weatherings, repointing and minor synthetic stone replacement.

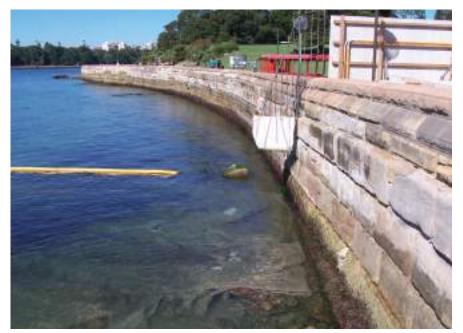
Substantial repairs have been undertaken over the last 20 years varying from dismantling and rebuilding wall areas including a new mass concrete footing to small synthetic stone patches. There are some areas of the seawall that have received no repairs for decades. In 2010/11 a land based inspection of the seawall was carried out in the presence of an engineering geologist, structural engineer and stonemason. Three distinct areas of the seawall were observed as subsiding. It was also noted that the remainder of the seawall was generally in good condition.

Recommendations for repairs with costings were documented for three areas of concern including short and long term solutions and structual advice.

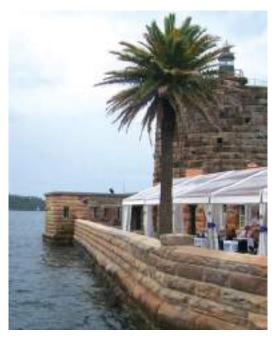
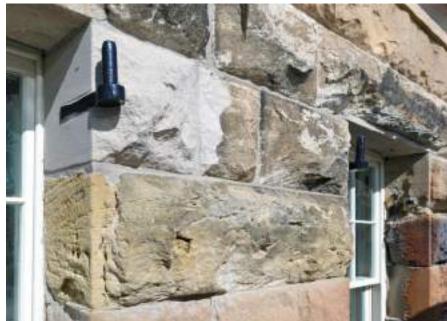
A three year program of 'catch-up' stonework conservation commenced in 2007. Conservation works have included repairs to the slipway and chimneys, desalination of major rooms, external repairs to the West Room and Tide Gauge Room, and repairs to the eastern seawall.

A number of investigations and strategies were also undertaken into drainage, paint and metal conservation. A number of the initiatives identified in these studies have been completed.

Given the success of the three year program, the program was extended to 2010/11 to complete all "catch-up" maintenance works. In this past year, a number of works identified in the paint and metal strategies were implemented, including consolidation of paint in the Martello Tower and breezeway, the removal of hard cement mortars and repointing in the Magazine Rooms, and the treatment of metal fixtures in the Gun Room and to the eastern barracks wall. In addition, repairs to the western seawall were completed and repointing works were undertaken to the lantern level of the Martello Tower and to the internal and external walls of the eastern seawall. A handrail was also installed in the Gun Room.

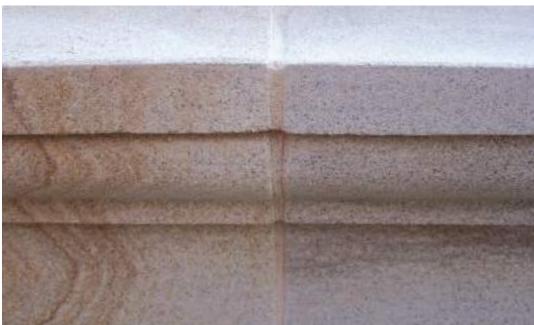
In March 2008 a stone safety inspection on the courthouse was carried out and a comprehensive report was prepared with recommendations for repairs.

In 2010/11, the repair works were undertaken including stone replacement, lead weatherings to the cornice, repointing and minor synthetic stone repairs.

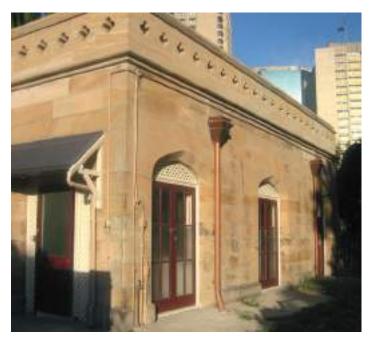
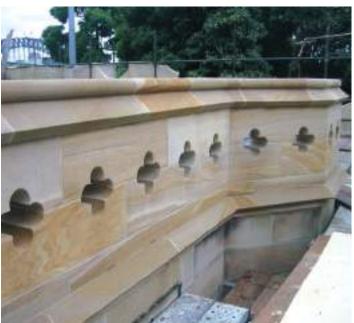
inspection it was noted that works undertaken in the 1970s left the building vulnerable to deterioration.

Stone conservation works commenced in 2010 and included the replacement of deteriorated stone to the parapet and string course, reinstatement of the lead sheet and slate roofs, removal of redundant fixings in stone blocks, synthetic stone repair and repainting of external timberwork.

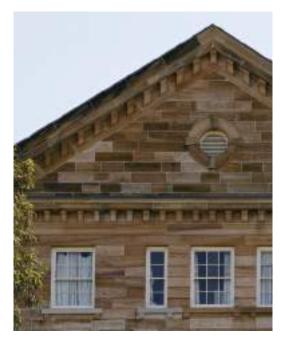
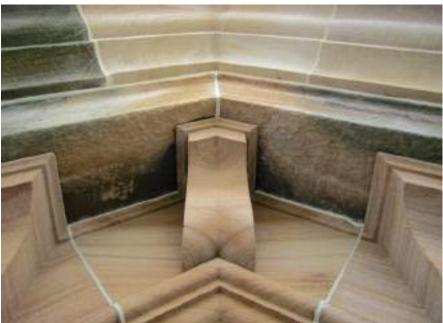
Stone safety inspections of the Boiler Hall and Office Building were undertaken in 2006 and 2008. At this time it was noted that the stone cornices and copings of both buildings were severely deteriorated, exacerbated by ineffective past repairs.

Stone conservation works undertaken in the 2010/11 program have included the replacement of deteriorated stone elements to the north façade of the Boiler Hall and the east and north façade of the Office Building, as well as brick repair and repainting. The works are part of a larger program of stone conservation works planned for the historic buildings.

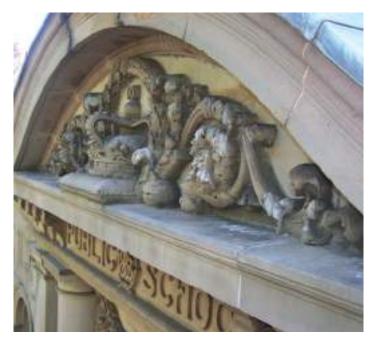
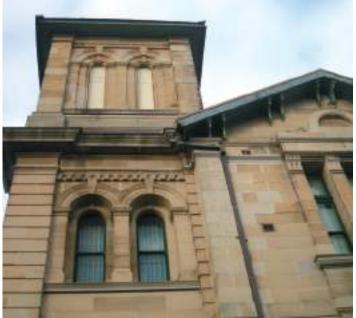
large imposing pediments and decoratively carved corner quoins which are considered amongst the finest and earliest surviving examples in Sydney.

In 2010/11 conservation work to the western gable was completed including a combination of stone replacement and lead weatherings.

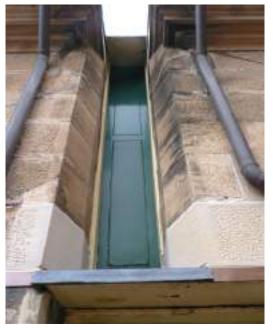
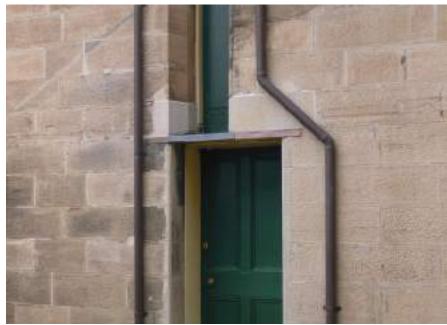
Sydney Observatory was built between 1857 and 1859. Its design combined the practical needs of an observatory and astronomer's residence with the impressive appearance of a public building in an Italianate architectural style.

In previous years, the Centenary Stonework
Program has fully funded conservation
works to the Sydney Observatory building.
In 2010/11 the last remaining façade Area
4D was conserved. Works included indenting
deteriorated stones, repointing open joints and
minor synthetic stone repairs.
